Salmon Beach Slope Landscape Management Plan

Draft

Environmental Services Department
City of Tacoma

October 3, 2017

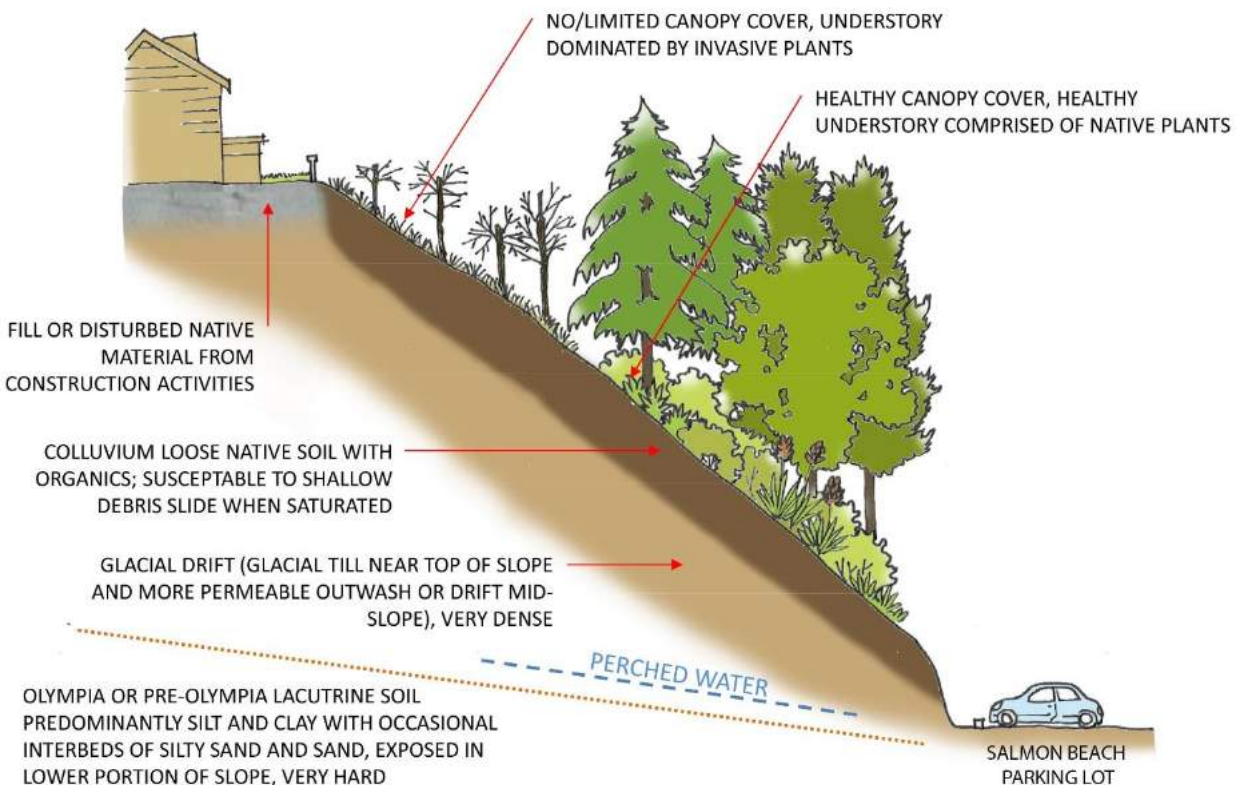
Exhibit 4. Slope Conditions Diagram

Throughout the Project Area the ground surface is typically mantled with a heterogeneous layer of loose colluvium. Colluvium develops on sloped surfaces through the weathering and loosening of soils higher up the slope that is then gravity emplaced through soil creep and sloughing. The material is similar in composition to the underlying native material, which is typically silty sand and gravel, but also contains organic matter debris and roots and is loose and unconsolidated (Exhibit 4).

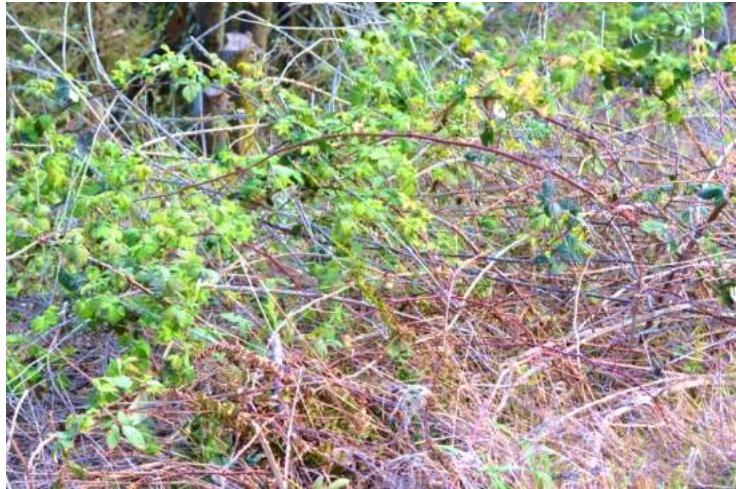
Exhibit 5. Himalayan Blackberry Growing at the Top of the West Slope

Himalayan Blackberry (*Rubus armeniacus*) is the most commonly occurring invasive species within the Project Area, and dominates the upper slopes. The thick and aggressive growth of Himalayan Blackberry on the upper slopes prevents the establishment of native species, and in many locations this species is spreading to adjacent native understory areas. English Holly, Morning Glory, English Ivy and Scotch Broom were also noted in the Project Area. Scotch Broom was found sparsely throughout the Project Area in open canopy areas and sparse aggregations of Morning Glory and English Ivy were noted, primarily in the upper elevations of the Project Area next to private residences.

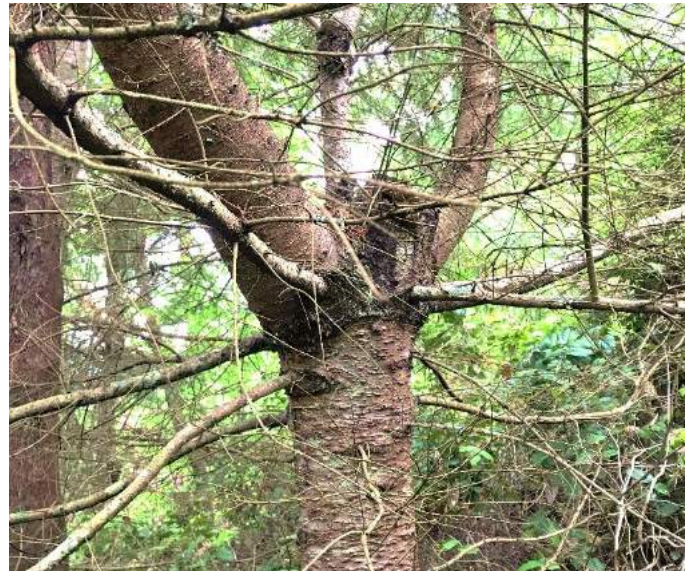
Exhibit 6. Topped Douglas Fir near the Top of the Project Area.

The topping has primarily been observed in Douglas Fir trees, which

has resulted in abnormal weak growth, pathways for decay and produced dense crowns with multiple leaders. In addition, large areas of Madrone trees are experiencing significant crown dieback due to mismanagement and disease, particularly on the southwest slope of the Project Area. The reduced canopy coverage has enabled invasive species to take hold and crowd out the native understory, particularly along the top of the slope.

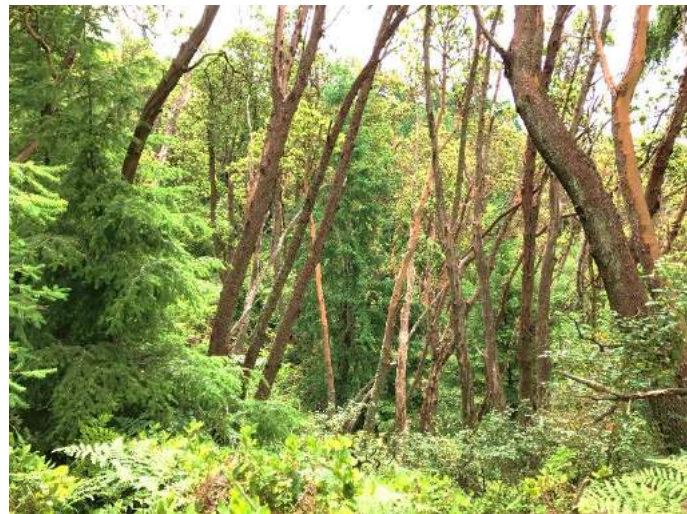
Exhibit 7. Madrone crown dieback on the southwest slope of the Project Area.

Trees are considered hazardous when all or a significant portion is likely to fail with a high risk of causing injury, damage, or disruption to a target (Smiley et al. 2011). Risk is determined when there is a target of concern within the area which would be affected if the tree were to fail. Targets specific to hazard potential include: public roadways, parking lots, sidewalks, persons and/or work crews within or adjacent to the Project Area, and critical infrastructure. Salmon Beach Road and the parking lot for the Salmon Beach community represent the only significant targets at risk of damage or disruption by hazard trees within the Project Area. Outside of the presence of a target, a tree failure is not considered a hazard. However, keeping existing trees healthy is important as damage caused by tree failure is often compounded on steep slopes, as the resulting soil disturbance has the potential to cause further erosion and slope failure.

As part of this plan, it is recommended that hazard tree assessments be conducted regularly where there are potential public targets and within active work areas, and subsequent remedial tree work be conducted as necessary to mitigate the hazards to the road, parking lot or overall slope stability, as outlined above. Hazard tree mitigation work should be conducted based on the tree risk assessment recommendations of an ISA certified arborist prior to work crews performing any vegetation management activities.

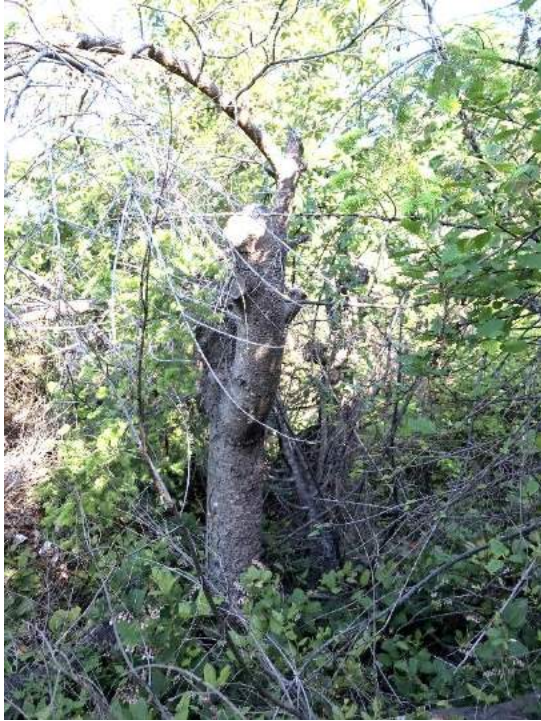
A. Previously topped Douglas fir tree, now dead.

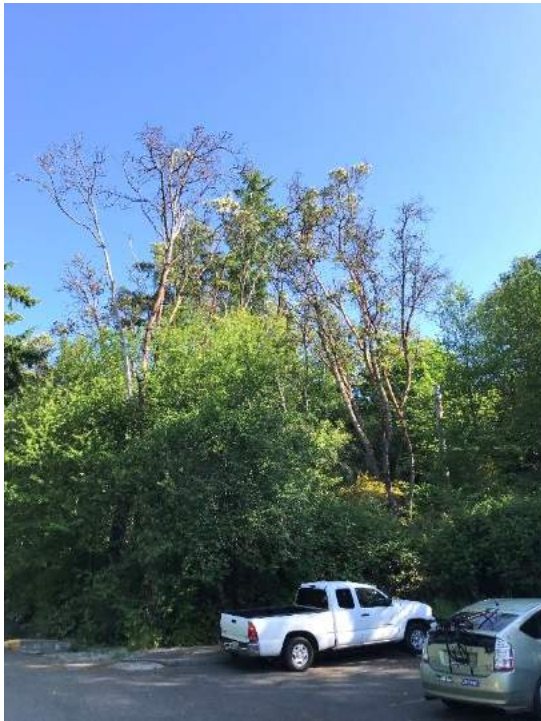
B. Madrone trees located in the northern portion of site, dead or dying.

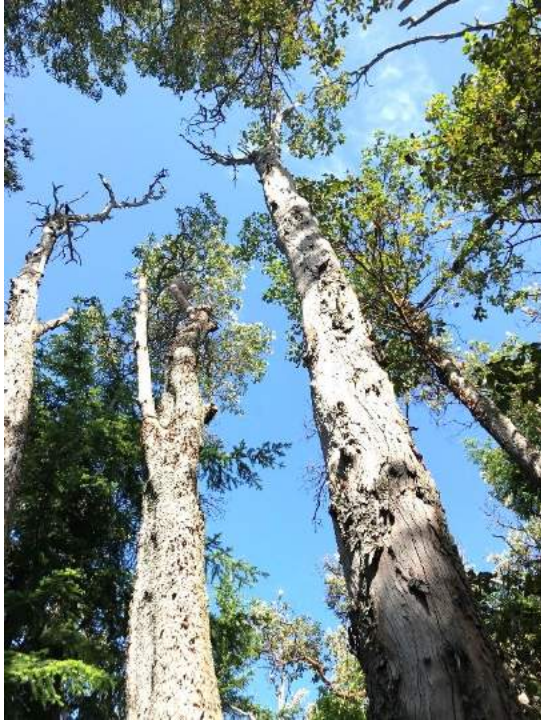
C. Previously topped Douglas fir trees, dead or dying.

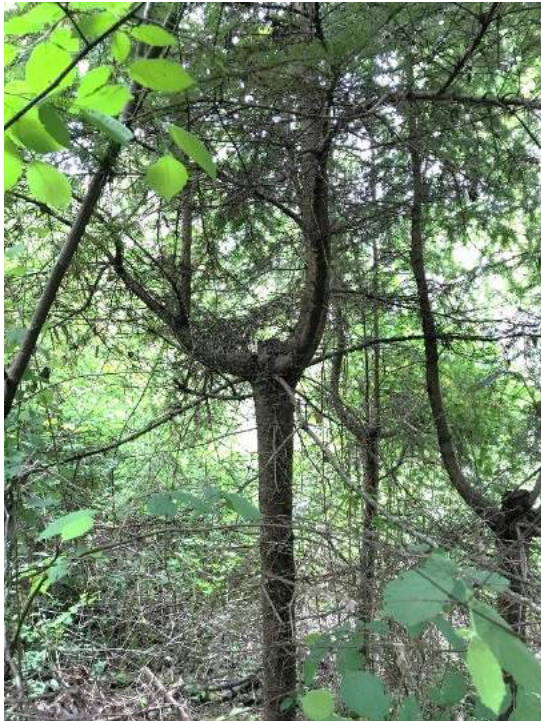
D. Previously topped Douglas fir tree.

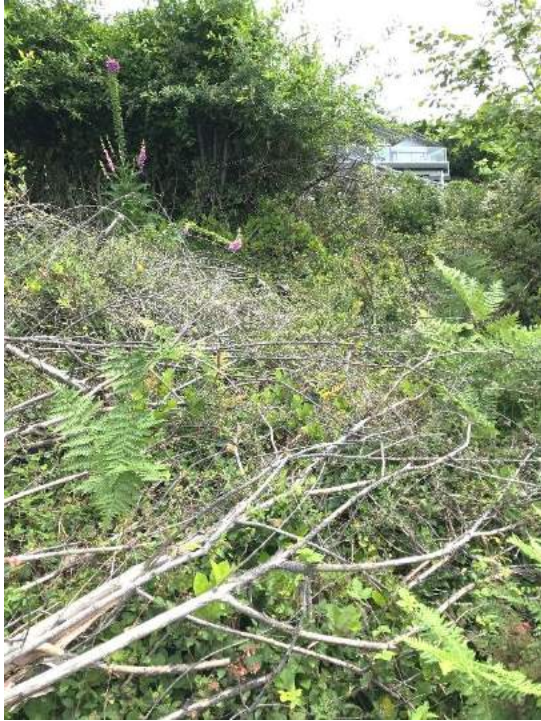
E. Invasive overgrowth on upper slopes devoid of canopy trees.

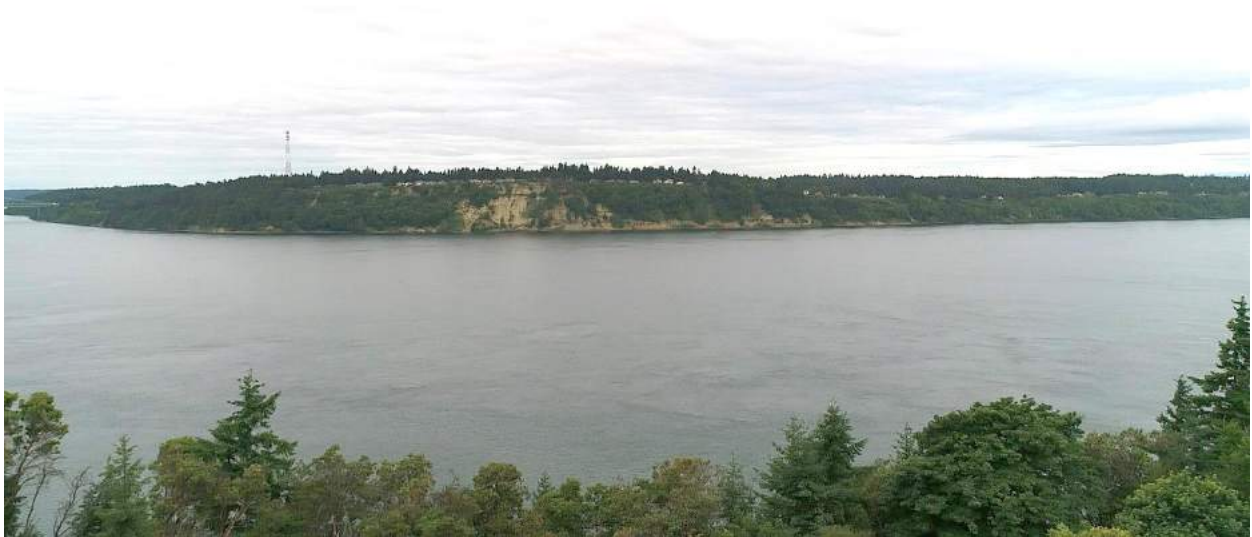
F. Current view from vantage point of private homes, midway along slope looking west (el. 240).

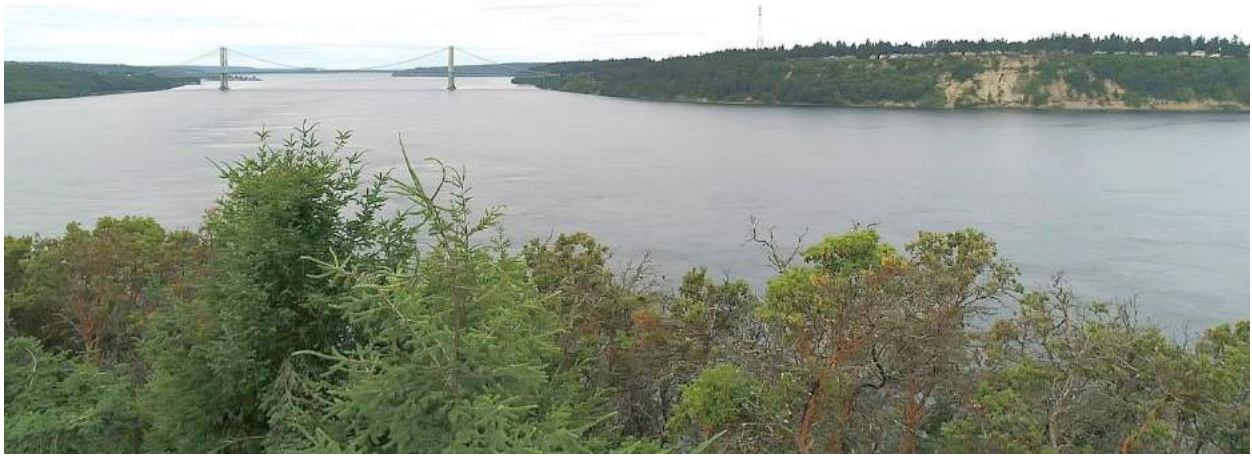
G. Current view from vantage point of private homes, southern end of project area looking southwest (el. 240).

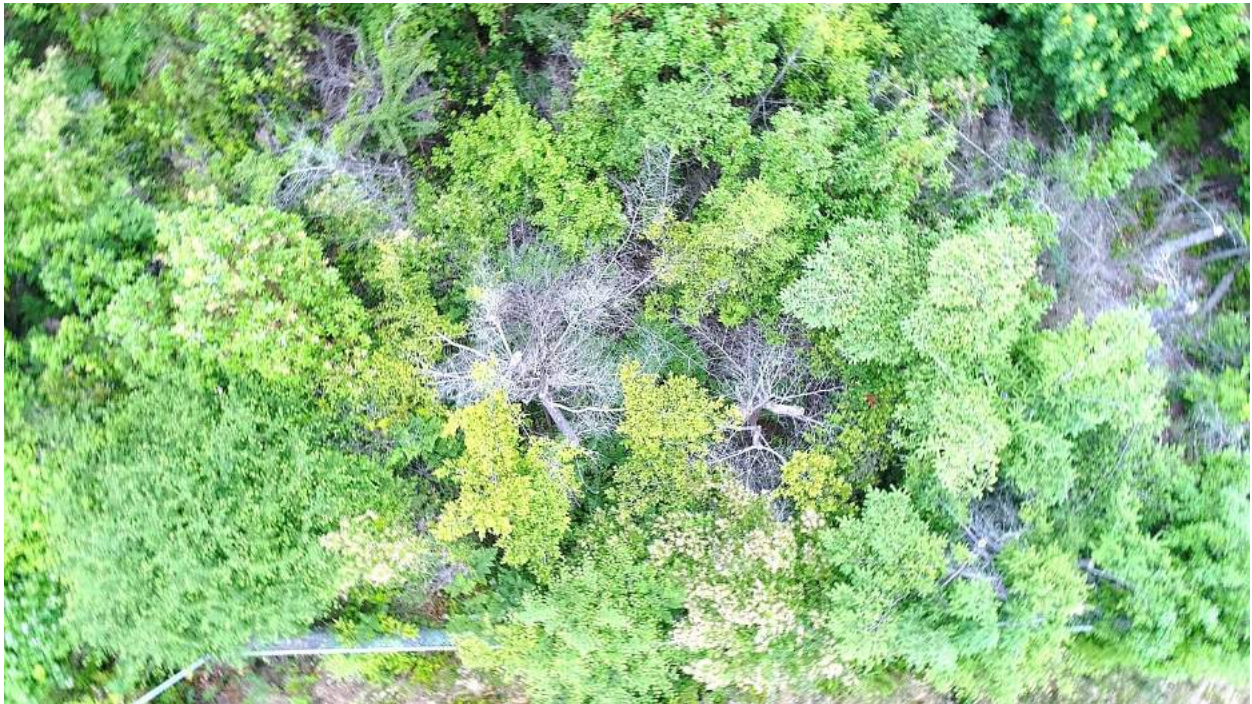
H. Aerial view down of dead or dying Douglas fir near top of slope.

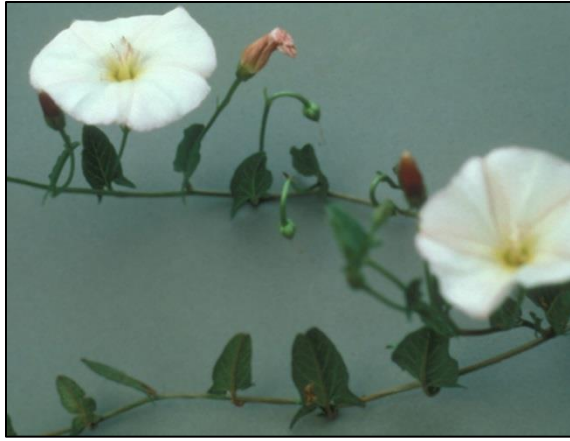
Field bindweed aka Morning glory (*Convolvulus arvensis*)

Field bindweed is a Class C noxious weed. This species is a perennial herbaceous plant with creeping and twining stems that grow along the ground and up through other plants and structures. It has an extensive system of rhizomes that can grow deep into the soil. Once established it can be nearly impossible to eradicate. It forms an extensive root system, often climbing or forming dense tangled mats.

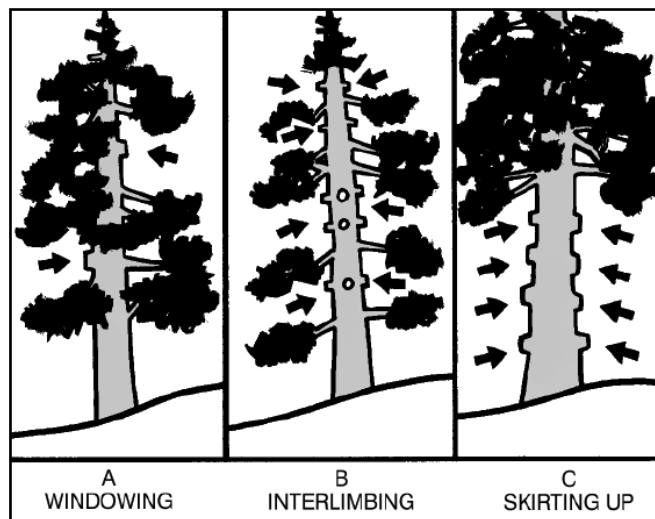
Figure 2: Alternative Pruning Practices for Conifers

Pruning for view clearance shall only be conducted on mature conifer trees with a DBH of 8 inches or greater. Pruning techniques for conifers are shown on Figure 2 and include the following:

- **Windowing:** Select branches may be removed to create a window through the existing foliage of the tree's canopy, and can be conducted for large, close-up trees that block a view. Windowing on one side of a tree may be balanced with pruning on the opposite side to keep a natural appearance.
- **Interlimbing:** Select branches are removed throughout the canopy to allow more light to pass through and reduce the wind resistance of the tree.
- **Skirting up:** The tree is limbed from the bottom up, which allows for a line of sight. This technique should be used for mid-range conifers located near the slope crest.

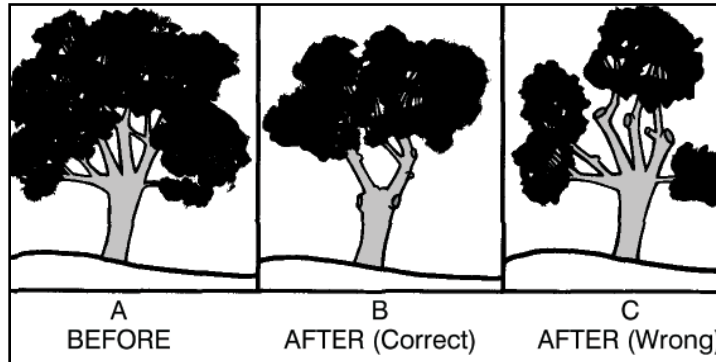
Figure 3: Pruning Practices for Broad Leaved Trees

Select branches should be removed to reduce view obstructions while maintaining a natural tree appearance as shown on Figure 3.

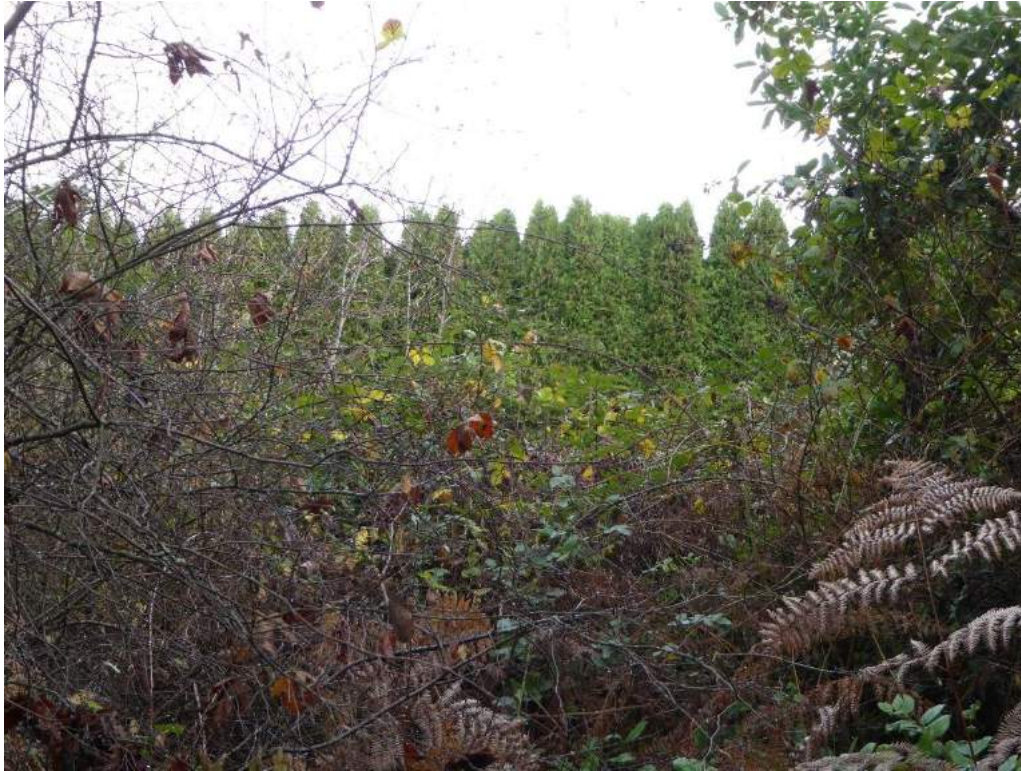
Figure 1 - Himalayan blackberry on upper slope.

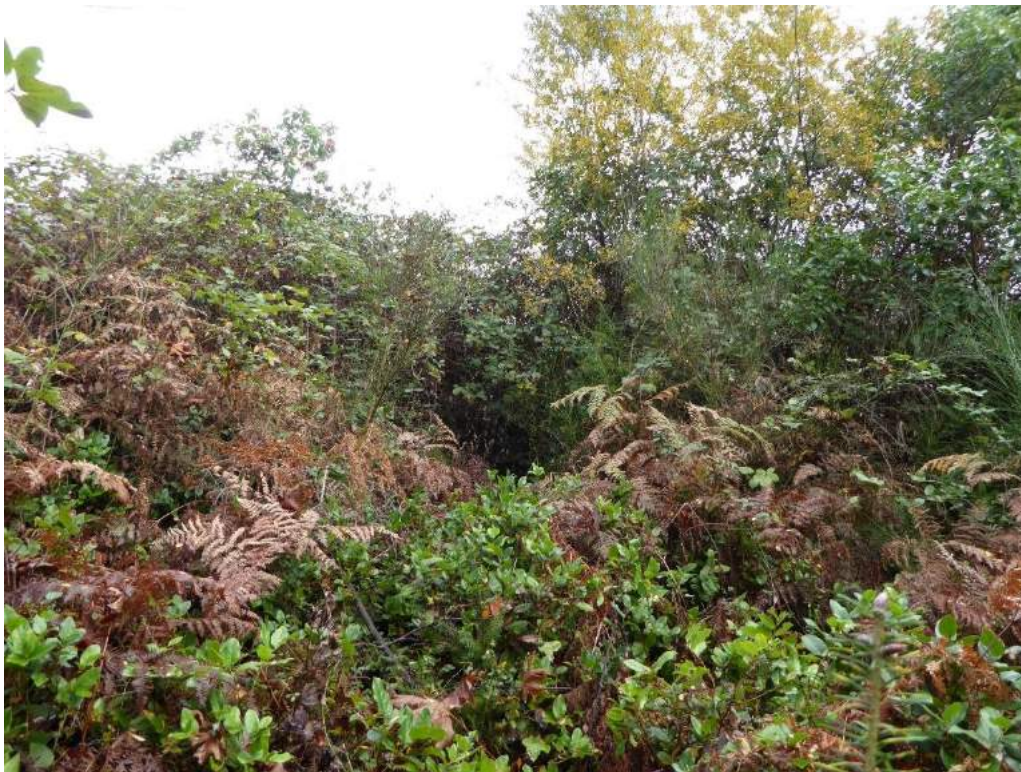
Figure 2 - Scotch Broom and Himalayan blackberry over running native vegetation in Zone B.

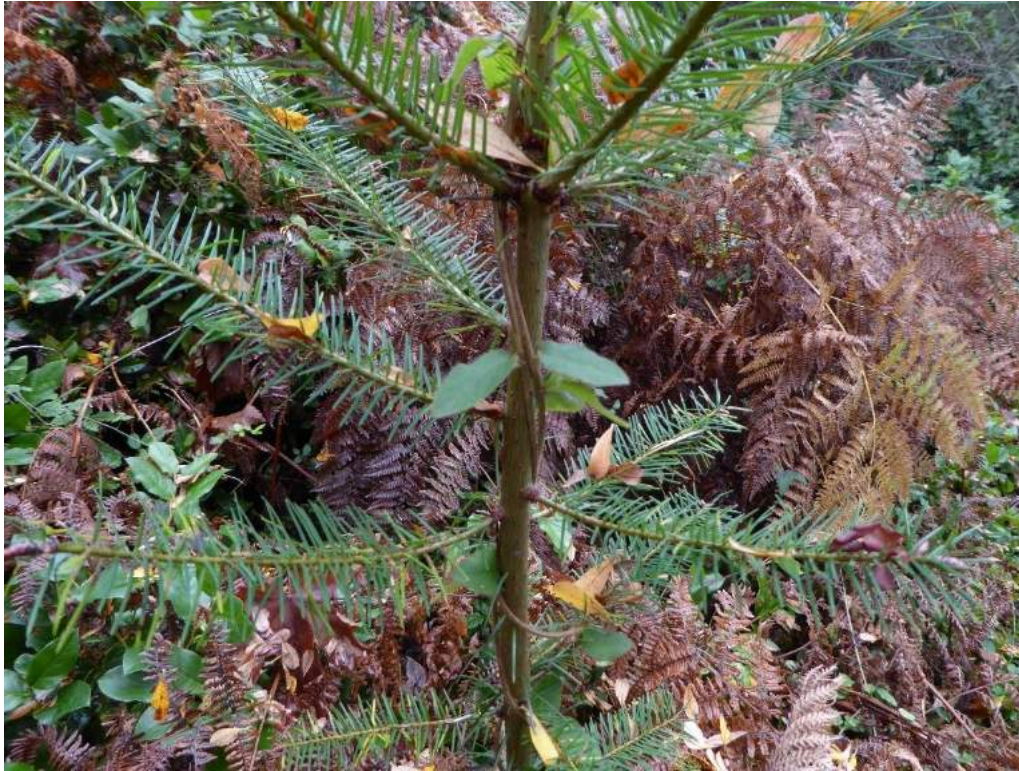
Figure 3 - Bindweed growing on sapling Douglas-fir.

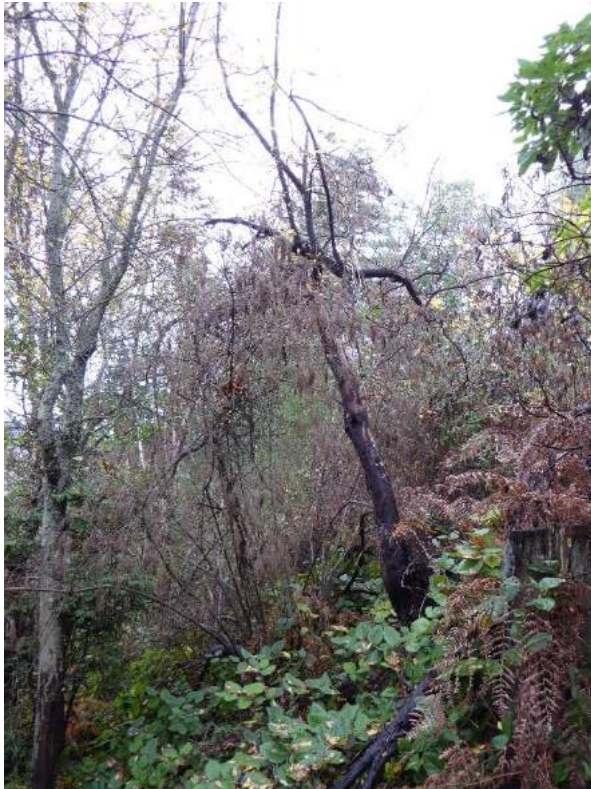
Figure 4 - Topped madrone has never re-sprouted and is now dead.

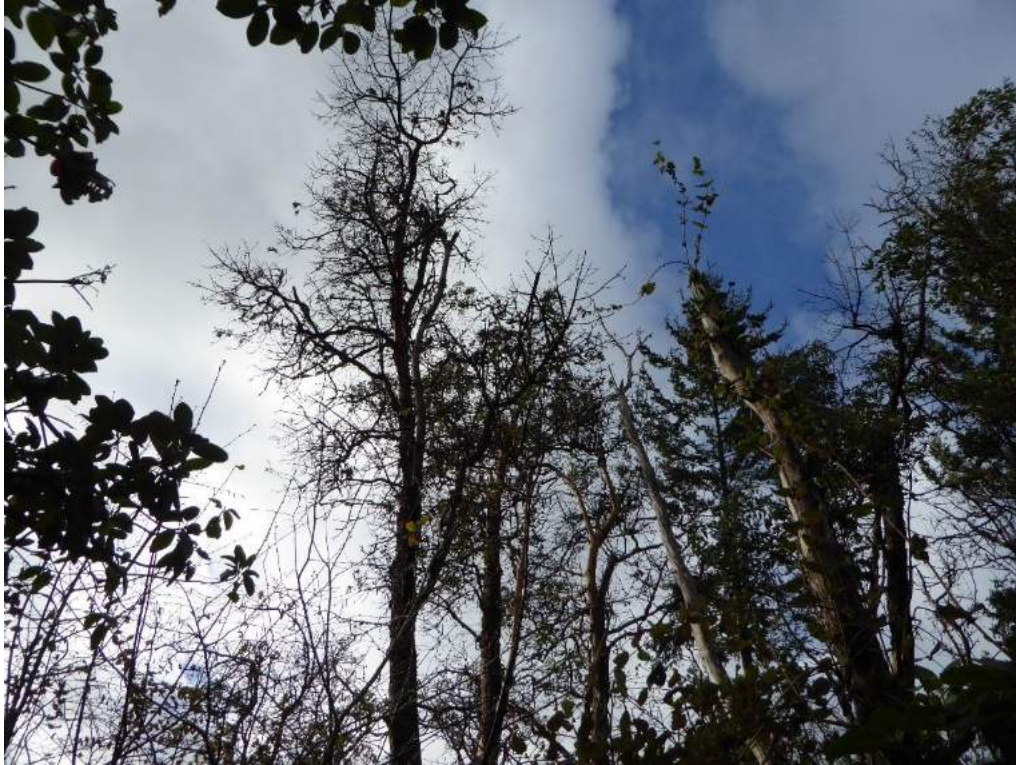
Figure 5 – Stand of madrone trees in advanced decline with little chance of recovery.

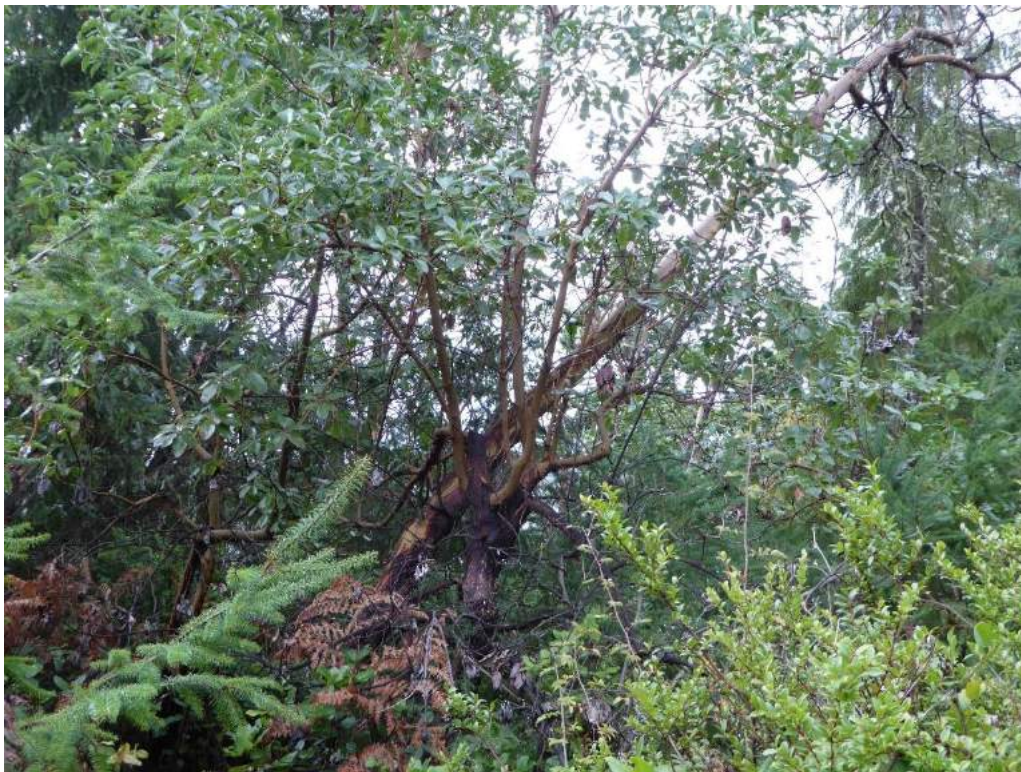
Figure 6 - Madrone showing regrowth, but no follow up management.

We observed a low number of smaller madrone trees that were topped and re-sprouting (see Figure 6). The sprouts on the trees appeared to be in good health, however, the main trunks have indicators of disease. In my opinion, these trees likely have a short useful life expectancy. The plan provides guidelines to approach cutting the madrone trees including follow-up pruning to reduce the number of sprouts and cutting back to laterals at specific heights. We did not observe any indication that follow-up pruning had been performed.

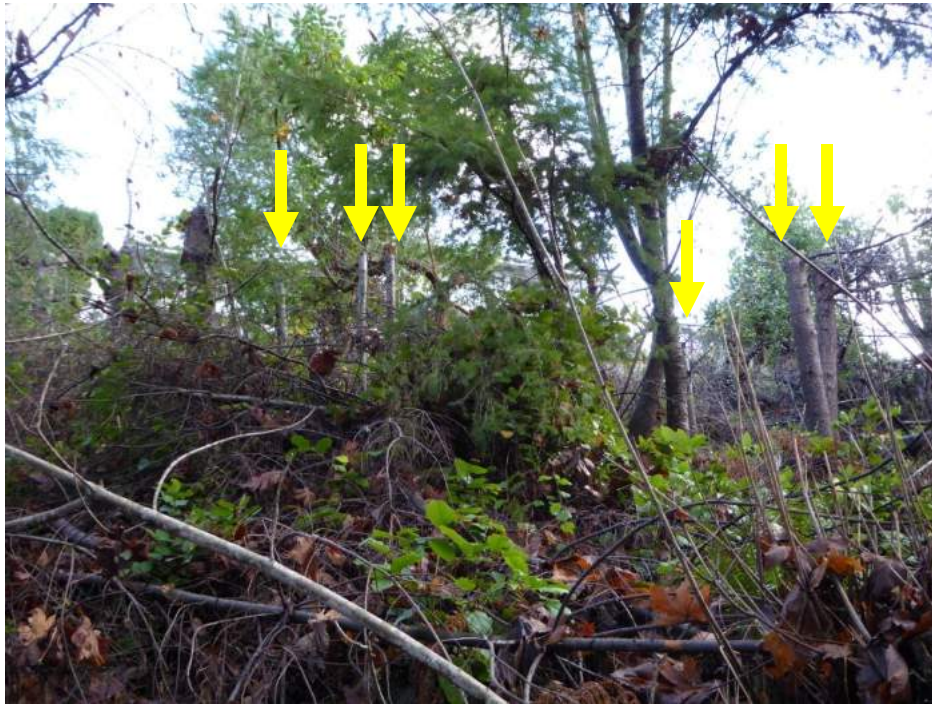
Figure 7 – The yellow arrows point to Douglas-fir trees that were topped and were to be managed in a shrubby form but have since died.

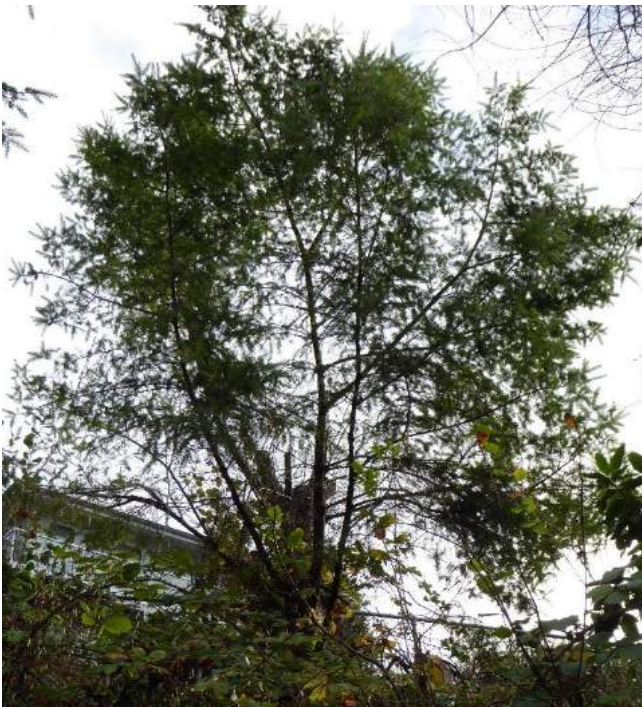
Figure 8 – One of the few topped Douglas-fir trees with regrowth that has not been managed.

Topping is not consistent with American Nation Standards Institute (ANSI) best management practices. The extent of pruning conducted on site is also not consistent with the PMVP where it specifically calls out that the industry rule of thumb that when pruning a tree, no more than 25 percent of the live crown should be removed in any year's pruning. While some of the trees have been able to sprout with new growth, many of them have died (see Figures 7 through 9).

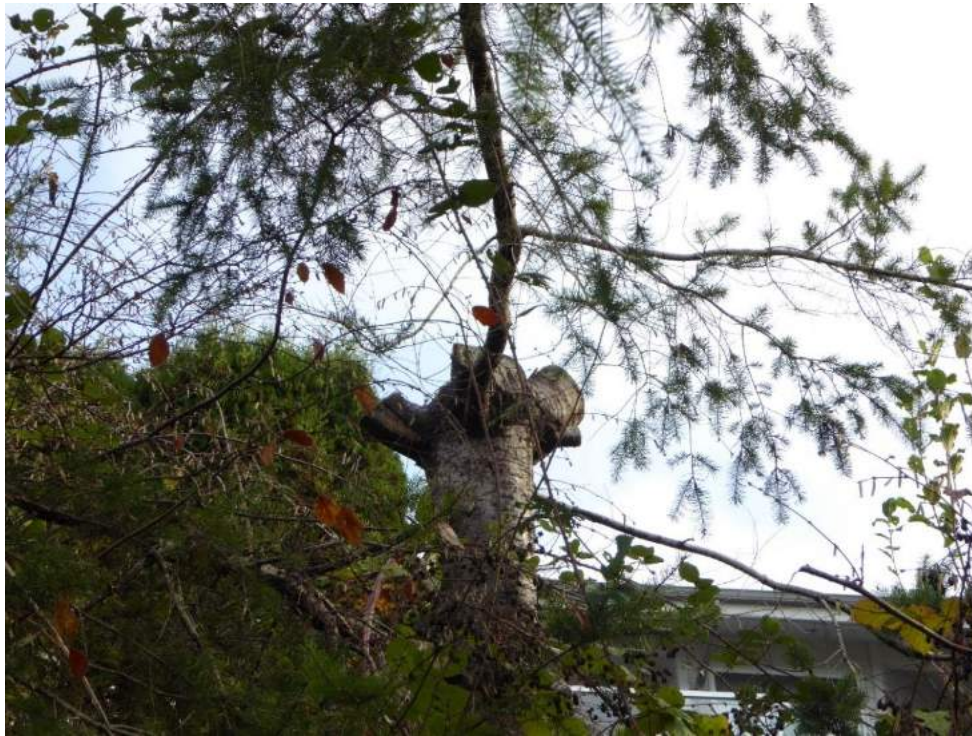
Figure 9 - Topped Douglas-fir, one live branch surviving. The pruning does not comply with ANSI A300 standards or the pruning guidelines outlined in the management plan.

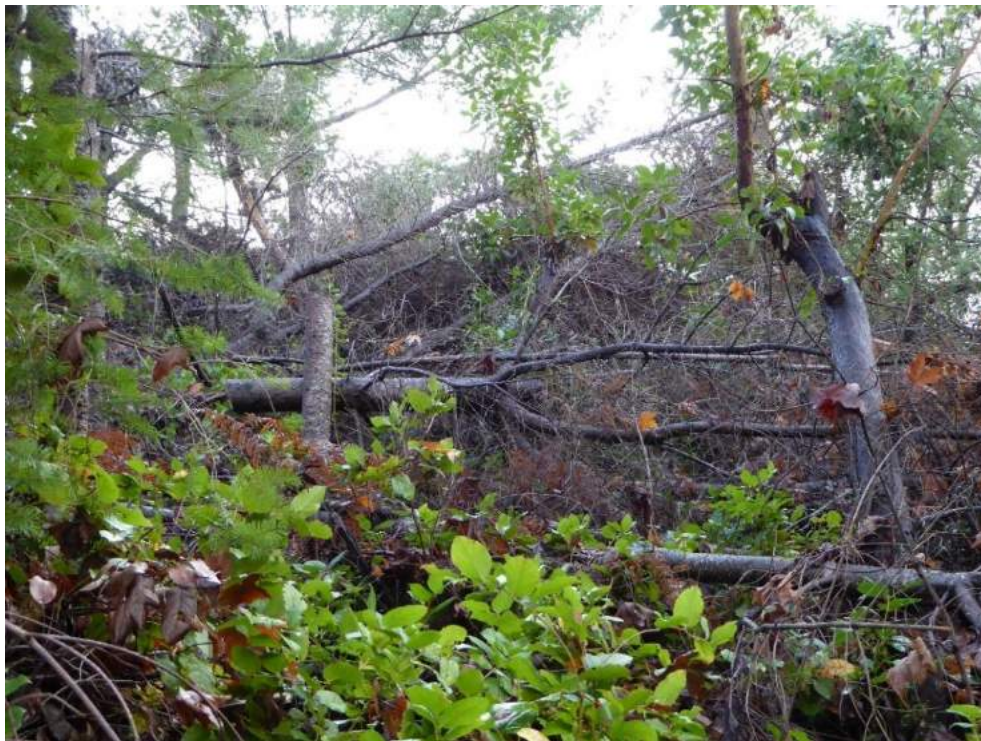
Figure 10 – Douglas-fir slash remains where it fell.

The plan states that 80-percent of the Douglas-fir slash should be removed from the site or chipped and all branches and stems should be lopped or scattered throughout the site. These should be cut to sections no longer than three feet in length and should be made to lie flat on the ground, not covering the healthy native plants such as salal (*Gaultheria shallon*). I agree with this approach. This may have happened in the initial pruning phase but has not occurred in recent pruning activities; instead, the dead wood appears to have been left where it fell (see Figure 10) covering native plants.

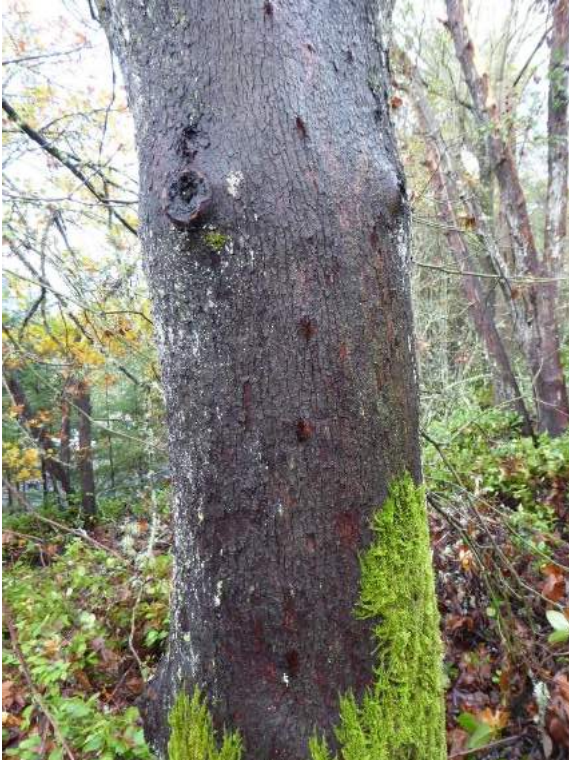
Figure 11 - Evidence of spike use on a Pacific madrone tree that was not turned into a snag and is still alive.

Another ANSI A300 standard and a guideline in the management plan is that no tree climbing spurs are to be used on trees that are to be pruned but can be used on trees to be removed and trees to be turned into a wildlife snag. We saw evidence of spikes being used on live trees including Douglas-fir and Pacific madrone trees (see Figure 11).

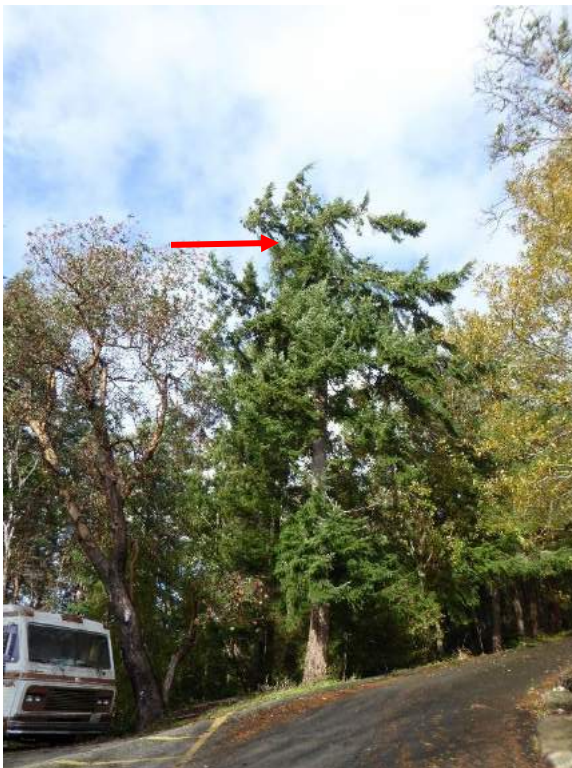
Figure 12 - Topped Douglas-fir across the road from the subject parcel.

Zone C appeared to have the pruning restrictions followed, however, we did notice that some pruning was performed offsite of the designated parcel. We do not know if permission was granted to perform these reductions, but thought that our findings should be included here (see Figures 12 & 13).

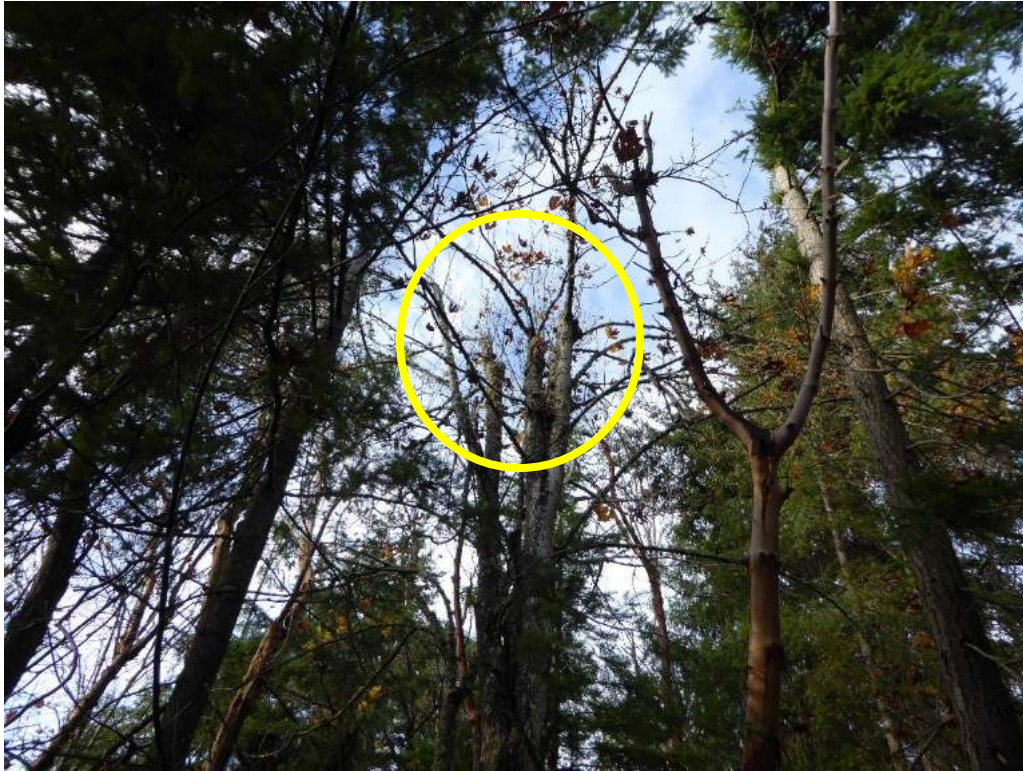
Figure 13 - More trees topped across roadway.

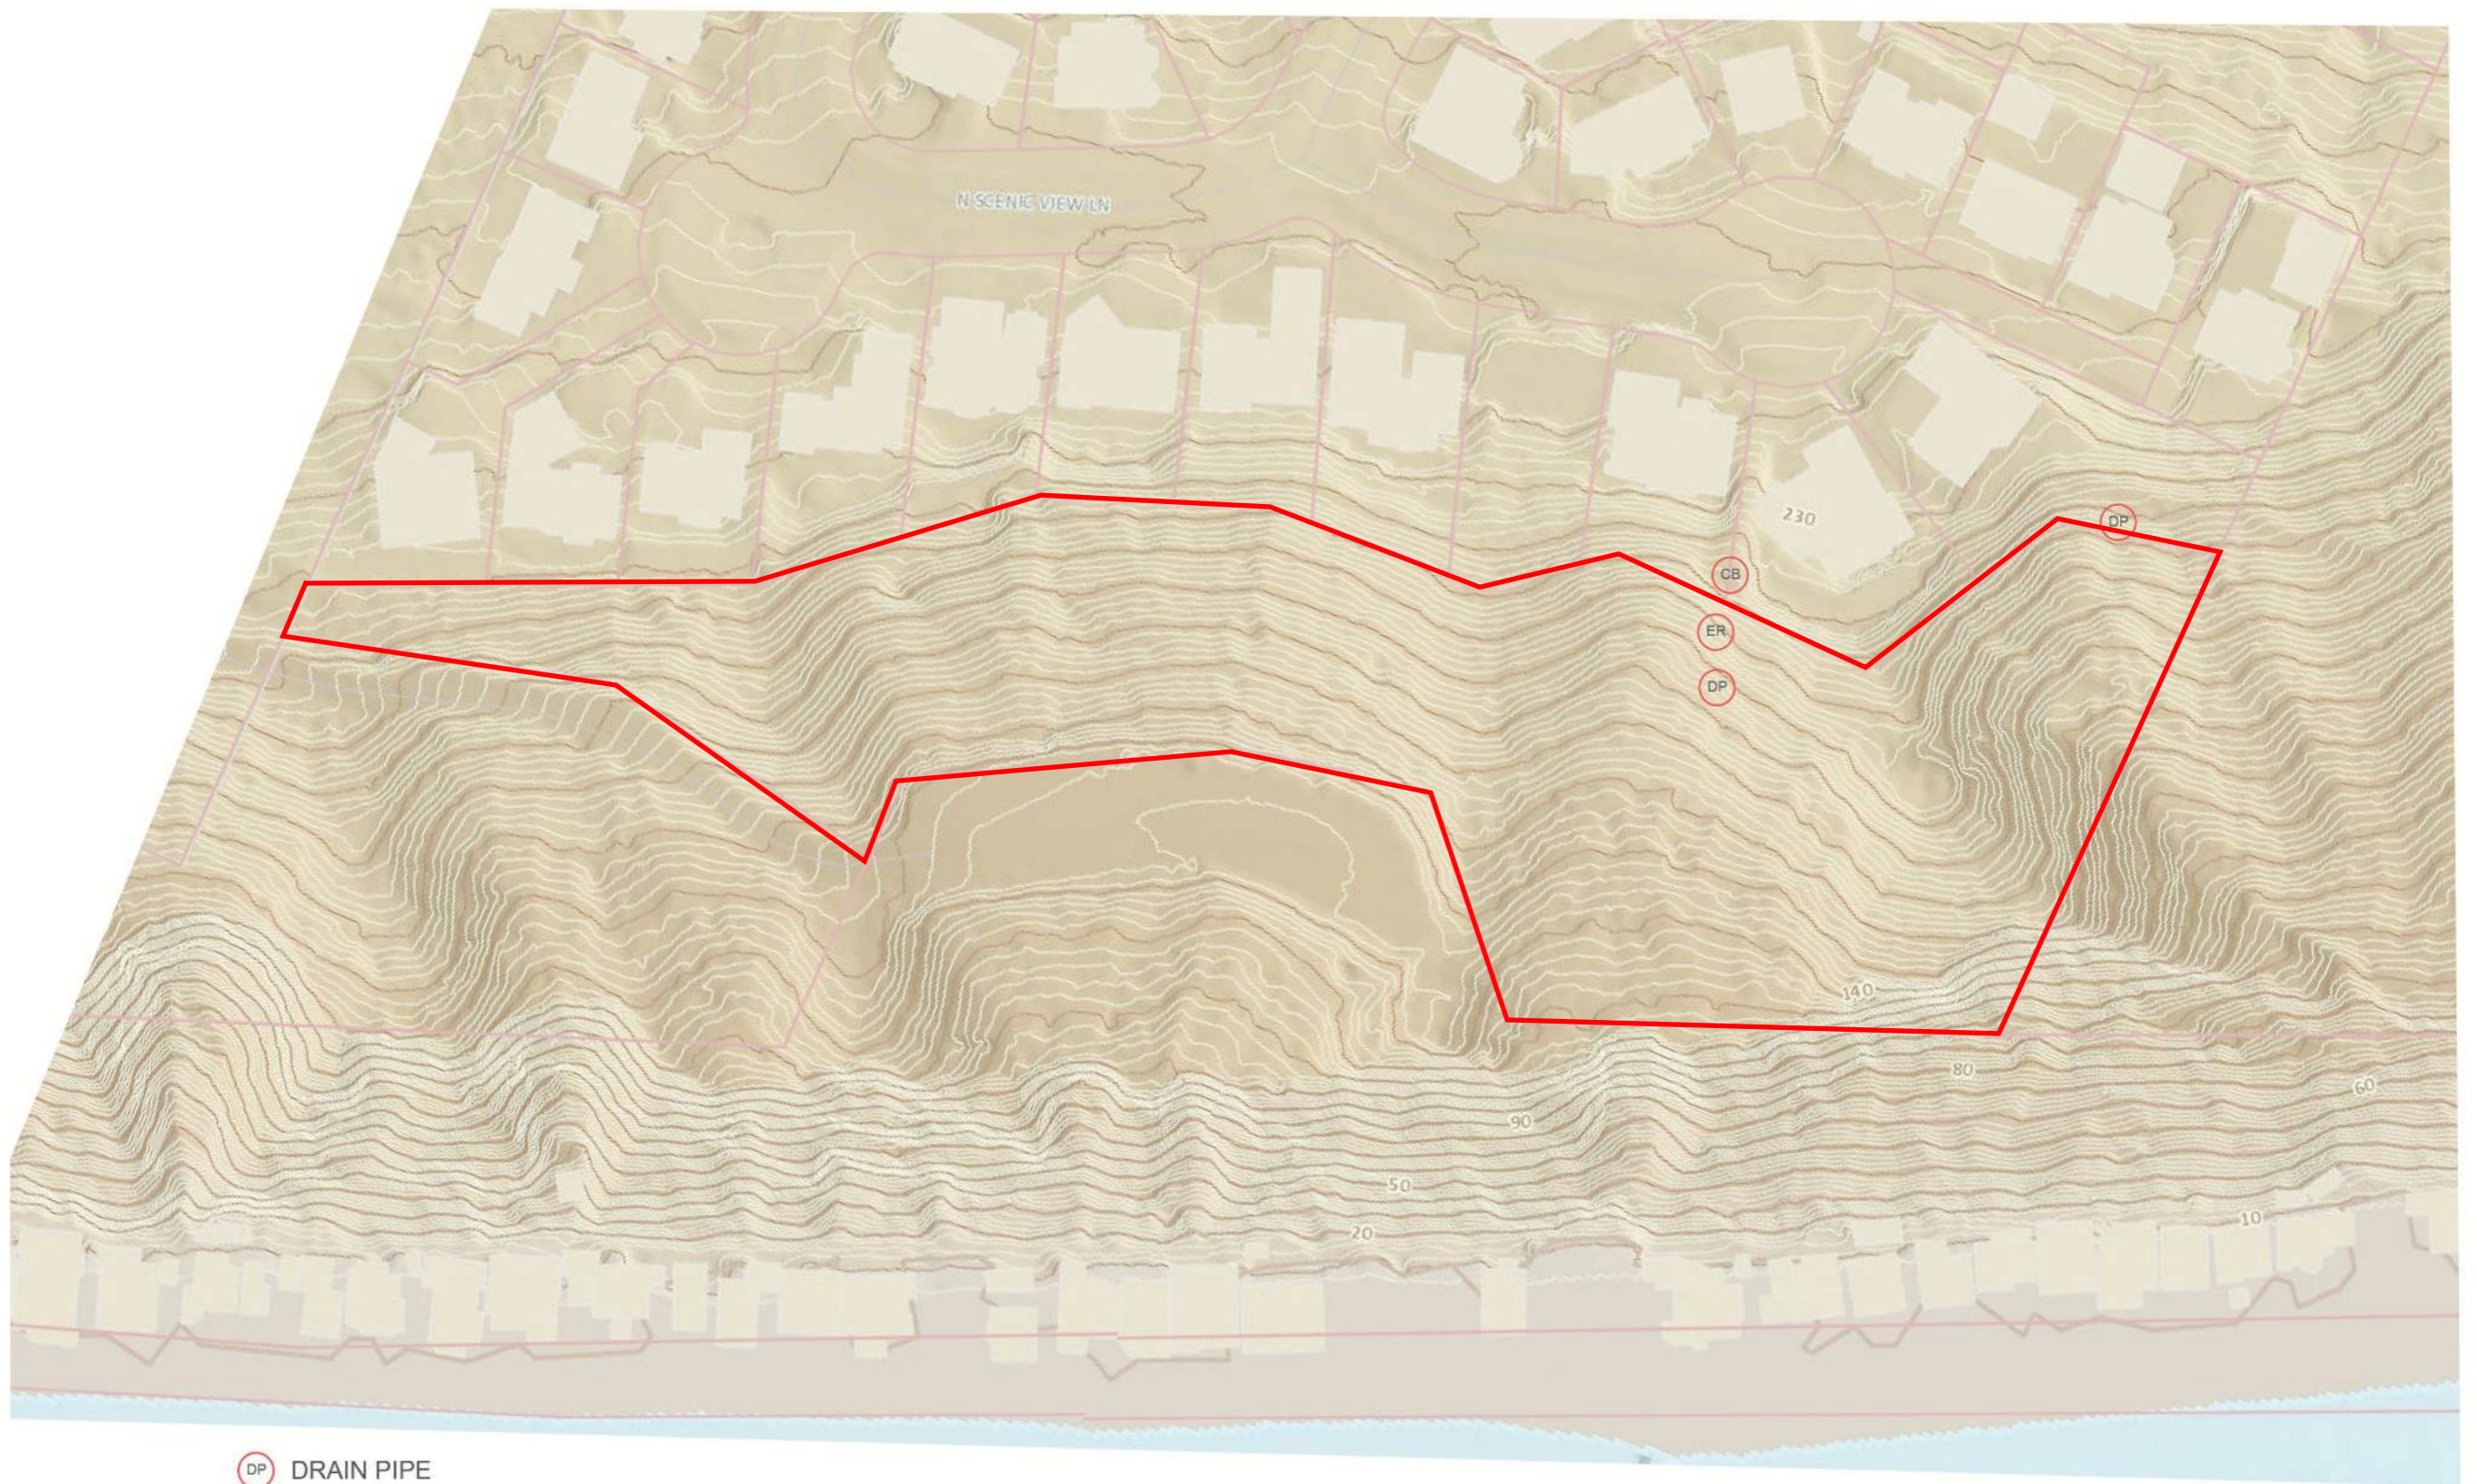
Appendix J: LiDAR Map

The topography in the upper half of the slope consists of a series of deep scalloped drainages separated by narrow topographic ridges (Appendix J). These features are likely the result of historic large earth slump type landslides following deglaciation. Evidence of recent deep seated activity was not observed.

- DP DRAIN PIPE
- ER SURFACE EROSION EXPOSED SOIL
- CB OVERTOPPED CURB
