# **CITY OF TACOMA: VISION ZERO ROAD SAFETY AUDITS**

RSA TECHNICAL MEMO #1: SOUTH TACOMA WAY

JUNE 2024 | FINAL

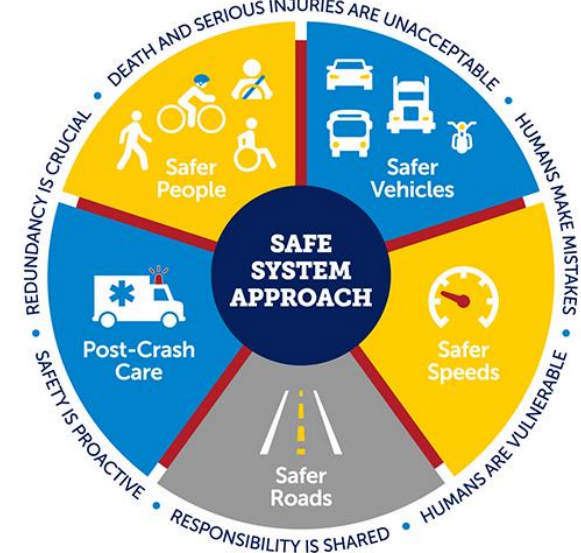
Figure 1: Safe System Approach Wheel (Source: FHWA)

Safe System Principles are illustrated in the outer ring of the graphic with the Safe System elements found on the inner ring: Safer People, Safer Vehicles, Safer Speeds, Safer Roads, and Post-Crash Care.

Safe System Principles are illustrated in the outer ring of the graphic with the Safe System elements found on the inner ring: Safer People, Safer Vehicles, Safer Speeds, Safer Roads, and Post-Crash Care.

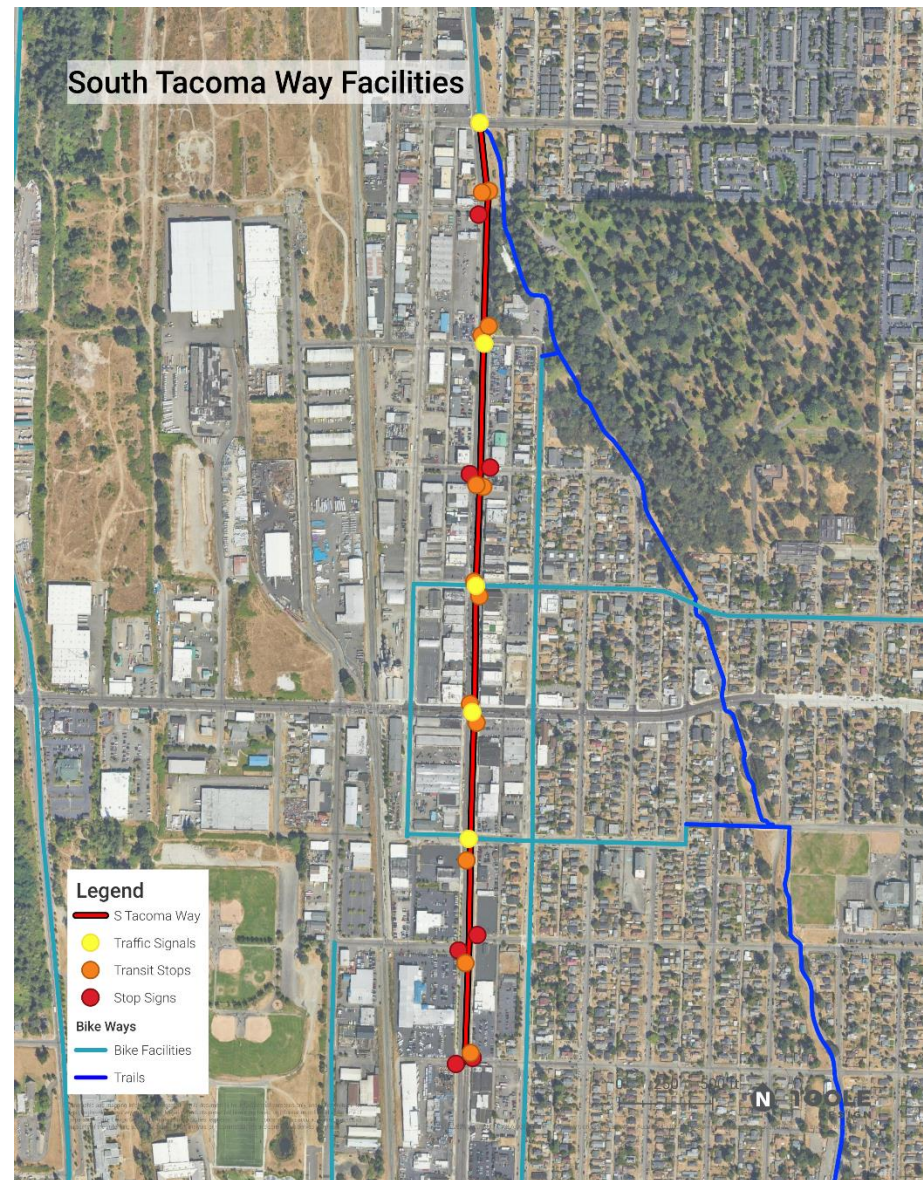
Figure 5: South Tacoma Way Facilities

Figure 5 displays facilities along South Tacoma Way. The map includes locations of existing bicycle facilities, traffic signals, stop signs and bus stops.

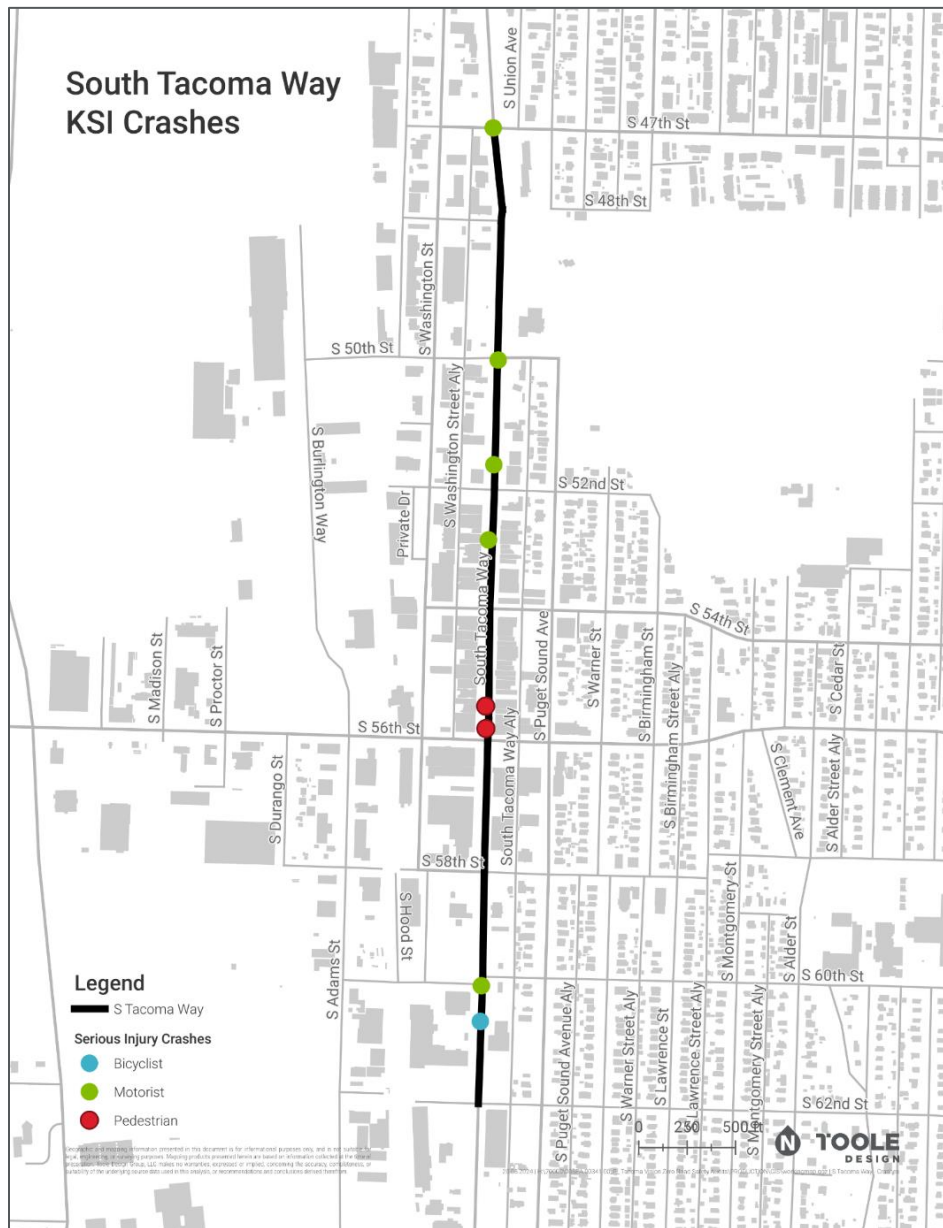
Figure 6: S Tacoma Way KSI Crashes Map

The following sections include tables summarizing the killed and serious injury (KSI) crashes from 2017 to 2023 (Tables 2 and 3). Table 2 displays the crash mode and severity of crashes along the segment from 2017 to 2023. Figure 7 and Figure 8 illustrate the crash diagrams. Each crash includes a corresponding number based on crash location from north to south. The corresponding number in the collision diagrams relate to the ID column in Table 3, which includes additional crash details. Appendix B includes the S Tacoma Way Speed Study conducted in 2021 showing that about 80 percent of vehicles speed through this corridor per the Total Study Speeding Fact summary table for allbound travel. Speeding is defined in this study as traveling one or more mph over the speed limit. Appendix C includes traffic volume data collected in 2021 showing the amount and classification of vehicles passing through this corridor.

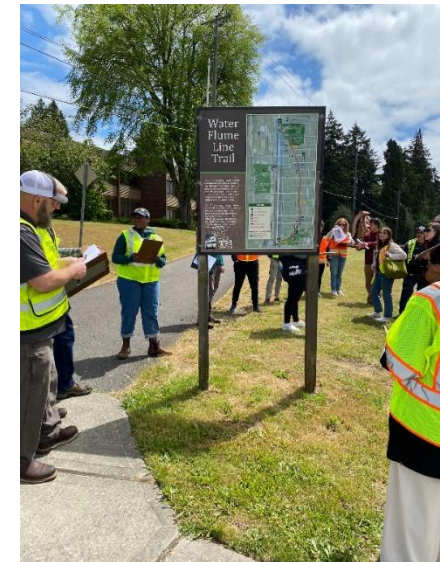
End of Water Flume Lane Trail at S 47<sup>th</sup> St and S Tacoma Way

- The sidewalk disappears north of the intersection.
- The intersection needs better lighting.
- Existing bike lane north of S 47th is sub-standard. Need to decide on plan for bike facilities north of S 47th (protected bike lane or trail continuation).

- Add green bicycle lane for crossing intersection.
- Substandard crosswalk and limited sight distance on SW corner.
- Suggestion to review minor injury crash data for bicycle and pedestrians at this intersection.

- Need to modify planter hangers to not block pedestrian signal heads.
- Add pedestrian crossing countdown.
- Add Leading Pedestrian Intervals.
- Add pedestrian refuge islands.

- Businesses parking cars illegally causing sight distance issues.
- Gateway/placemaking strategy needed for business district and speed reduction zone. The limited ROW on West side of trail entrance has greater potential for gateway elements.

- Gateway/placemaking should include ped scale lighting on the trail and at intersection.
- Add 12" signal heads with reflective backplates.
- Consider protected/permitted left turns.

- Add right turn hardening with truck aprons as needed.

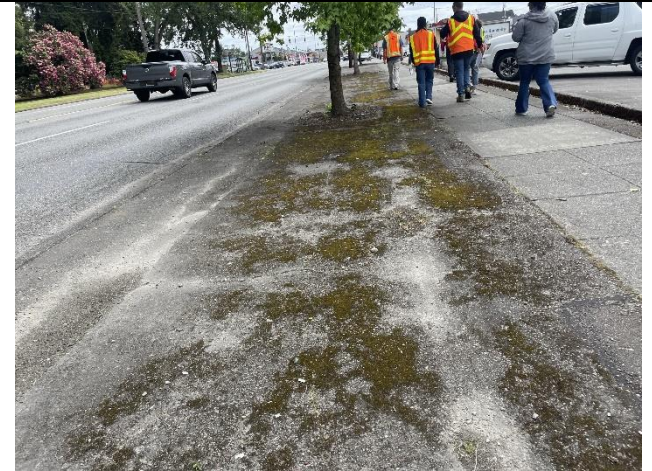
West side of street needs depaving between S 47<sup>th</sup> St and S 50<sup>th</sup> St

- The sidewalk is substandard along frontage. Curb is rolled and fails to protect sidewalk for motorists.
- Add curb along sidewalk on west side.
- Plant trees in landscape zone on east side.

- For depaving adjacent property, owner is responsible for vegetation unless it's a tree. Process is MOU with property owner.
- The sidewalk should be 7' wide minimum for arterial streets.

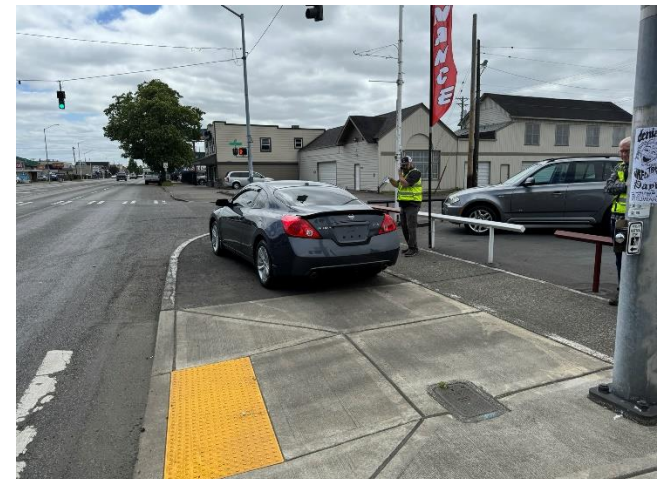
Dealerships habitually parking cars in pedestrian ROW

- Need more bus shelters/ benches at bus stops.
- Dealerships parking cars on plantings strips, obstructing sidewalks.
- Replace two-way left turn lane with raised center median.

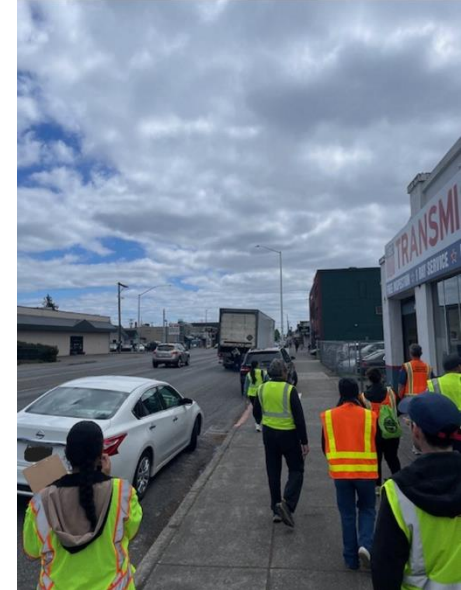
Freight loading/unloading happening in travel lane

- Bus stops are not in optimal locations or do not allow enough room for pedestrians.
- Freight loading and unloading happening in the ROW but should happen in alley.

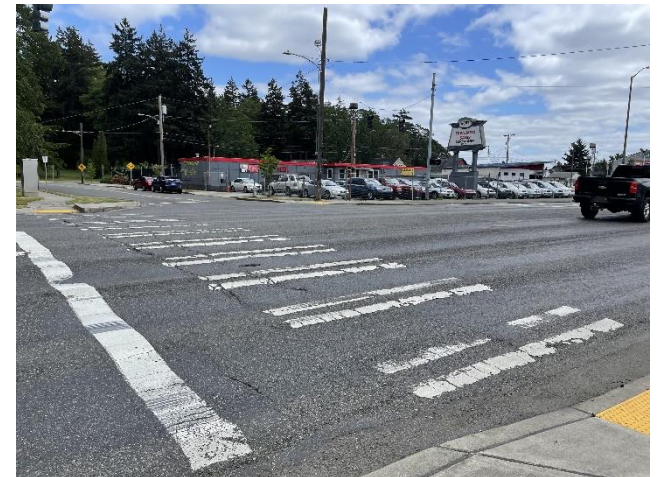
- Pedestrian crossing buttons are confusing. Could be updated.
- Roadway seriously concaved/ damaged. Needs improvement.
- Street parking begins south of here. Needs painted parking strip.
- Substandard ramps on the SW and SE legs of the intersection.
- Increase lighting at crossings and intersections.
- Add Leading Pedestrian Intervals (LPI)
- Install 12" signal heads with reflective backplates.
- Consider protected/permitted left turns.
- Add marked crosswalks.

Concaved roadway in need of improvement

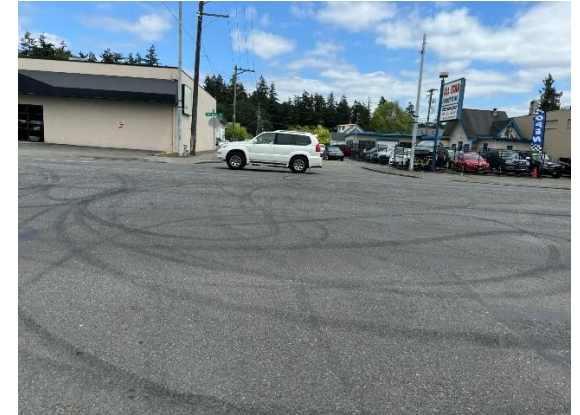
- Pedestrians need to cross approx. 68 ft.
- Crosswalk in unmarked and substandard ramps.
- Update pedestrian crossing.
- Suggestion to close off access to S Tacoma Way from driveway immediately south of intersection.
- Cars do donuts in this intersection.
- Add truncated domes.

Skidmarks in intersection showing cars frequently “do donuts” here

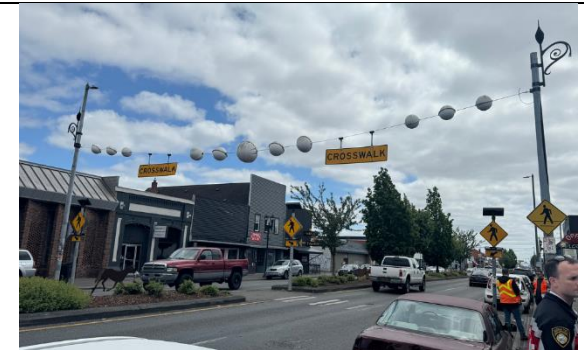
- Pedestrian scale lighting begins here.
- Ramps do not meet ADA requirements.
- Inline storm crossing.
- Explore if trees along center median landscape need to be limbed up.
- Add bike corral and parklets at various points of the NBD.
- Driveway access to S Tacoma Way should be closes to protect pedestrians and bus stop users.
- Upgrade midblock crossing with raised crossing.
- Update pedestrian beacon to Rapid Flashing Beacon.

Pedestrian median island between S 52<sup>nd</sup> and S 54<sup>th</sup>

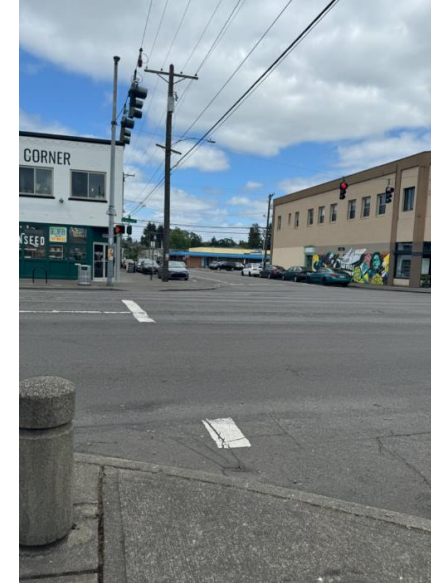
- There is limited lighting near intersection.
- Alighting from the back door bus is difficult and forces people into driveway area.
- There are substandard curb ramps here.
- South side of 54<sup>th</sup> St sidewalk needs repair.

No marked crosswalks at S Tacoma Way-S 54<sup>th</sup> St intersection

- There is evidence of cars doing donuts in intersection.
- This is a good intersection for crashworthy art.
- Add temporary or quick build curb bulb outs that don't obstruct bicycle infrastructure.
- Add marked crosswalks.
- Add marked green bicycle crossings.
- Install 12" signal heads with backplates/reflectors.
- Look into Protected/Permitted left turns.

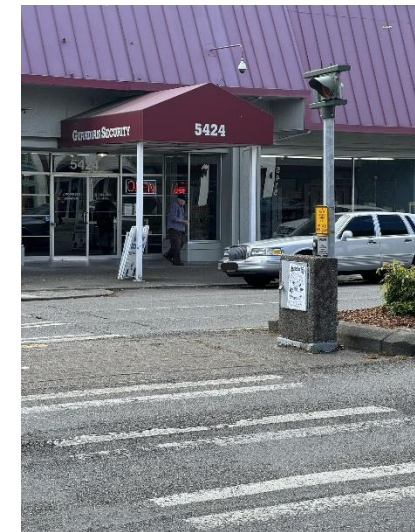
- Depaving /tree planting needed.
- Fire station emergency call routing outbound is more critical northbound on S Tacoma Way than southbound. Treatments to slow traffic would be less impactful to fire trucks on southbound leg. 1-2 speed cushions are possible, but more than that slows down outbound fire trucks significantly.
- Restaurant seating area is on sidewalk - Could be standardized not infringe on the pedestrian access route.
- Cafe seating location "sticking out " - designate amenity zones.
- Potholes near midblock crosswalk.
- Trees reduce clearance and visibility for pedestrian in the center median - what is the balance.
- Reestablishing street trees in "islands" with back-in angle parking could also help with managing the vehicle parking onto sidewalk areas.
- Tire marks (donuts) in crosswalk.
- Update pedestrian beacon to Rapid Flashing Beacon.

Crossing Island with dated pedestrian crossing beacons between S 54<sup>th</sup> and S 56<sup>th</sup>

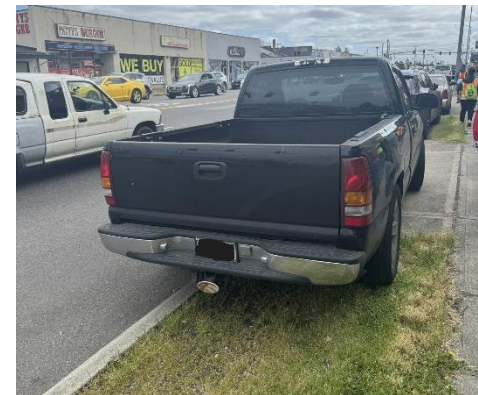
- Needs traffic calming and something to make pedestrians feel safe. There's lots of pedestrian traffic here and could increase depending on future development.
- Vehicles parking on strip near sidewalk restricting pedestrian access.
- Depaving / tree planting needed near sidewalk.
- Add raised centerline median along section.

Vehicles parking on strip near sidewalk restricting pedestrian access.

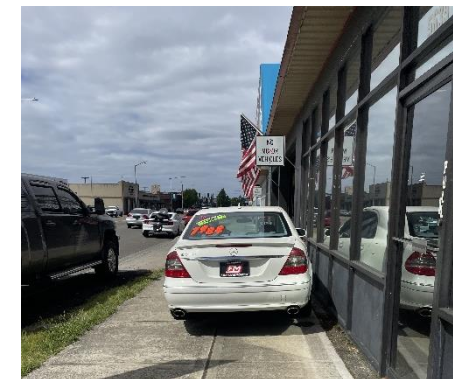
- Dealerships parking cars on sidewalk.
- There might or should be Sound Transit wayfinding to station on S Washington St.
- Roundabouts prevent the drag racing and donuts in the intersections better than other intersection treatments.
- There is increased speed on the roadway.
- On east side, overhead utilities conflict with proposed street trees.
- Here the road transition to 35 mph speed limit.

Dealership cars obstructing sidewalk path.

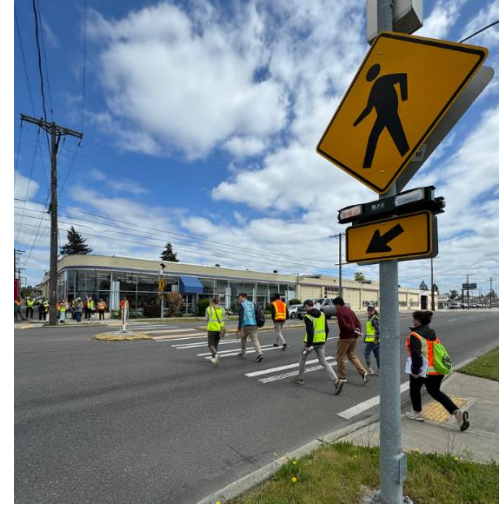
- Crossing is not allowed at the north side of the intersection.
- There's limited visibility to the flashing beacon due to trees.
- Upgrade the ped beacon to newer Rapid Flashing Beacons.
- RRFB is likely not appropriate given the number of lanes and travel speed.
- The median island is struck frequently.
- Improve lighting at intersection.
- Automated enforcement as folks enter the business district.
- Consider adding a median Rectangular Rapid Flashing Beacons.
- Add curb bulb-outs.

RRFB at end of project segment (S 62<sup>nd</sup> St and S Tacoma Way)
