CITY OF TACOMA: VISION ZERO ROAD SAFETY AUDITS

RSA TECHNICAL MEMO #2: SOUTH YAKIMA AVE

JULY 2024 | FINAL

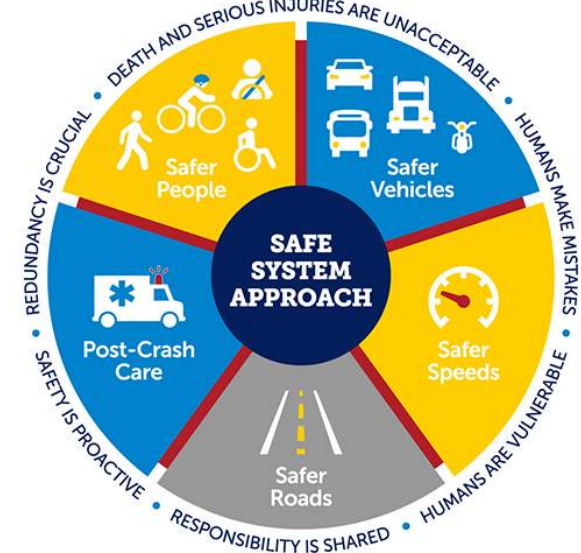
Figure 1: Safe System Approach Wheel (Source: FHWA)

Safe System Principles are illustrated in the outer ring of the graphic with the Safe System elements found on the inner ring: Safer People, Safer Vehicles, Safer Speeds, Safer Roads, and Post-Crash Care.

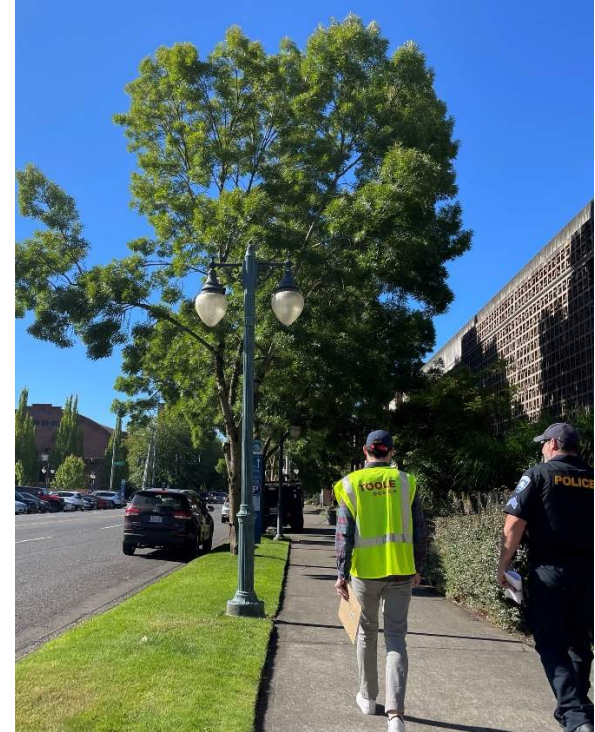
Pedestrian scale lighting between S 9th St and S 10th St

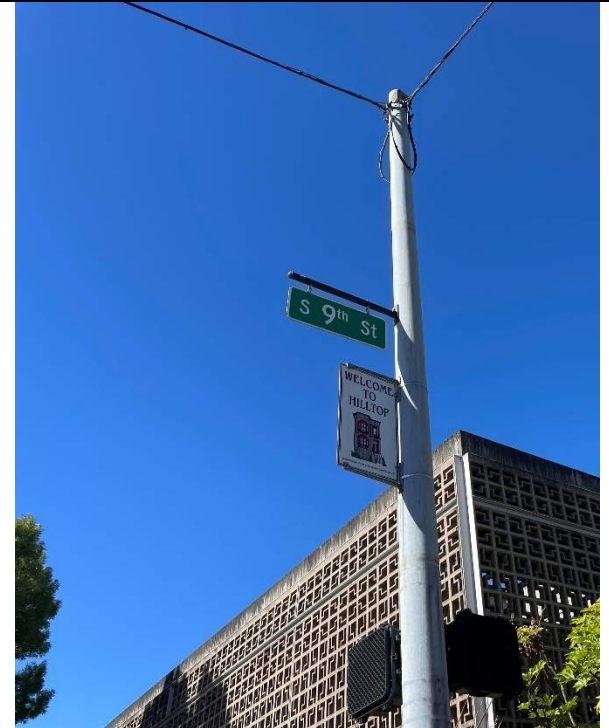
"Welcome to Hilltop" sign at S Yakima Ave and S 9th St

Changing "Welcome to Hilltop" signage from North-South facing poles to East-West facing poles.
Ideally on its own pole

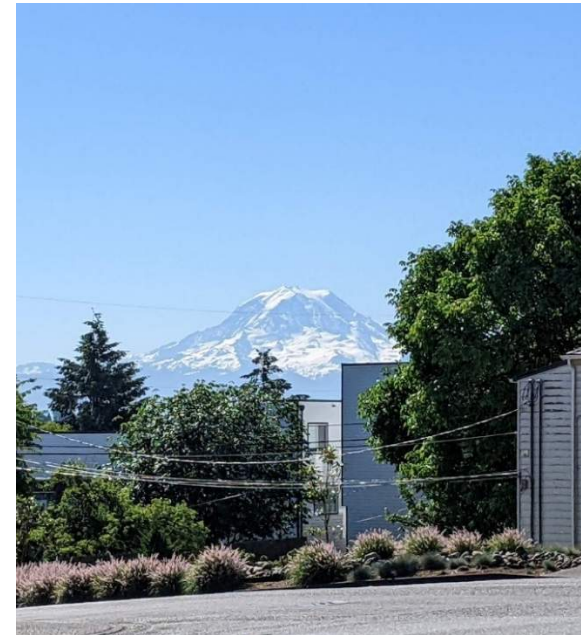
- No accessible pedestrian signals.
- No detection.
- 12,8,8 signal heads.
- No countdown pedestrian heads.
- No conduits.
- Only 2 streetlights.
- Appears to be some ADA compliant ramps.

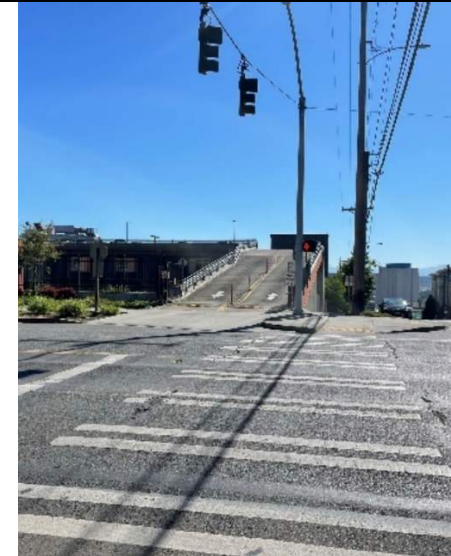
Right-out only driveway very close to S 13th St intersection

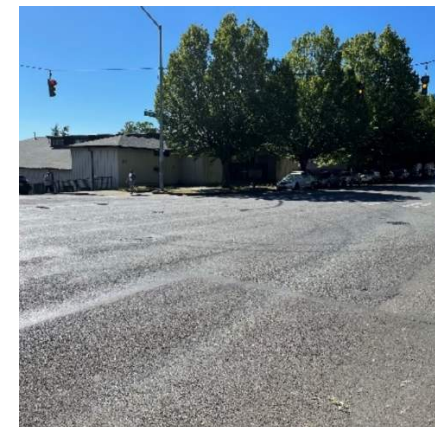
- S 13th St sign missing on north side of intersection.
- Tire marks from donuts.
- No curb ramp inventory data for southwest and southeast corners. Address tripping hazard at southwest corner. Install bulbouts for pedestrian visibility.
- Very awkward curb, planter strip, sidewalk setup on SW corner of S 13th St.
- To address all signal comments, signal system would need to be completely reconstructed. Signal comments:
 - No accessible pedestrian signals.
 - No detection.
 - 12,8,8 signal heads.
 - Existing countdown pedestrian heads.
 - Appears to be some ADA compliant ramps.
 - Minimal conduits.

Tire marks from donuts at S 13th St intersection

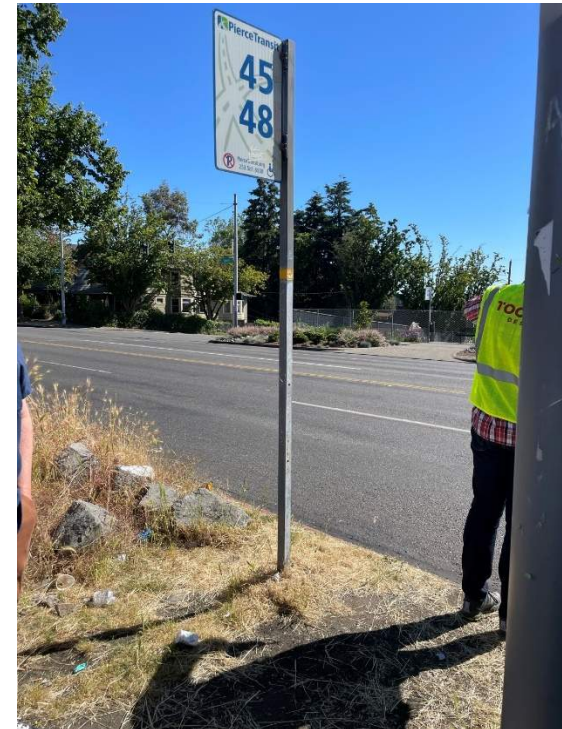
Bus stop at S 15th doesn't have front or rear pads.

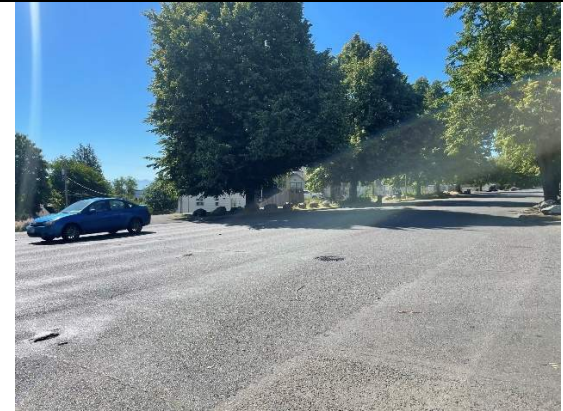
Large uncontrolled and unmarked intersection
at S 16th St

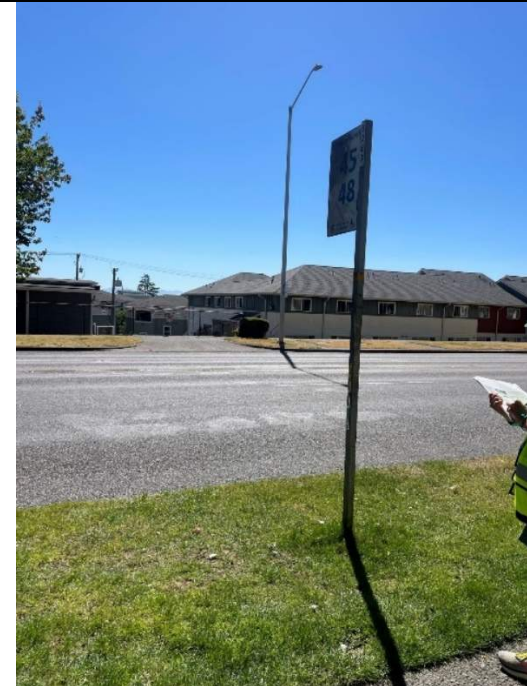
- Bus stop 3283 (southwest corner of S 17th St) needs min front and rear pads and perhaps pad for a bench/shelter, if ROW available.

Bus stop without front or rear pads at S 17th St

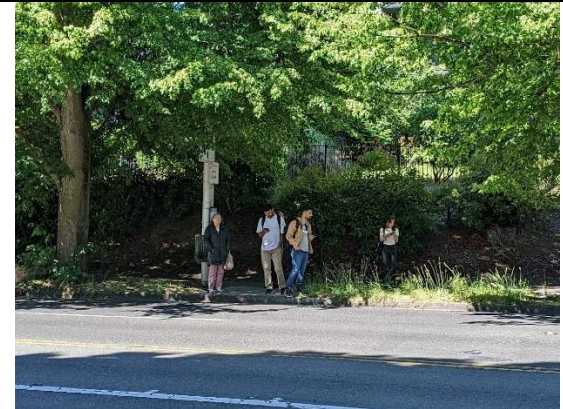
People waiting for bus with no bus shelter or benches.

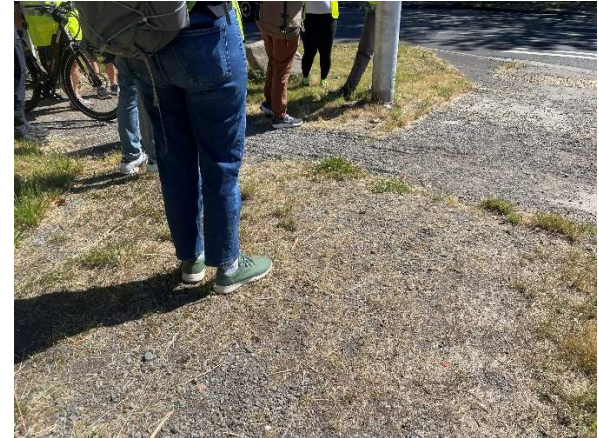
Dirt and gravel covering sidewalk at northwest corner near S 21st St

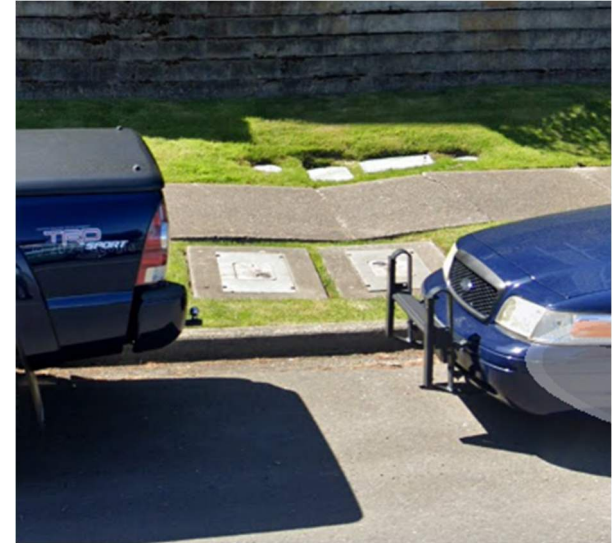
Sidewalk uneven and caving between S 21st St and S 23rd St

Widen sidewalks to 7' per COT standards for arterial roads, unless otherwise specified			✓	\$\$\$\$	-	CoT
	Upgrade existing storm inlet grates with parallel openings to new standard inlet grates or replace the whole structure		✓		\$- \$\$\$	-	CoT

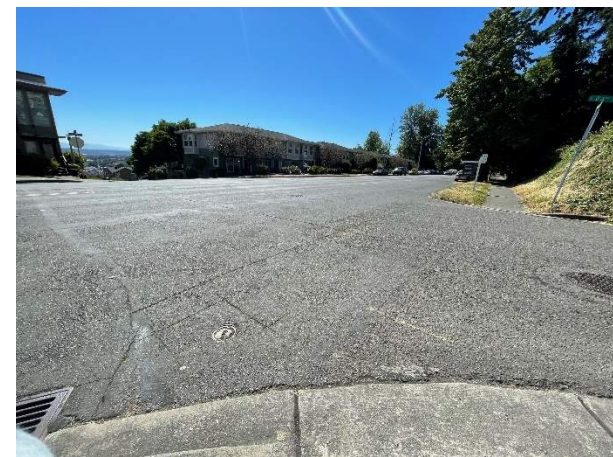
Large, unmarked intersection at S 23rd St

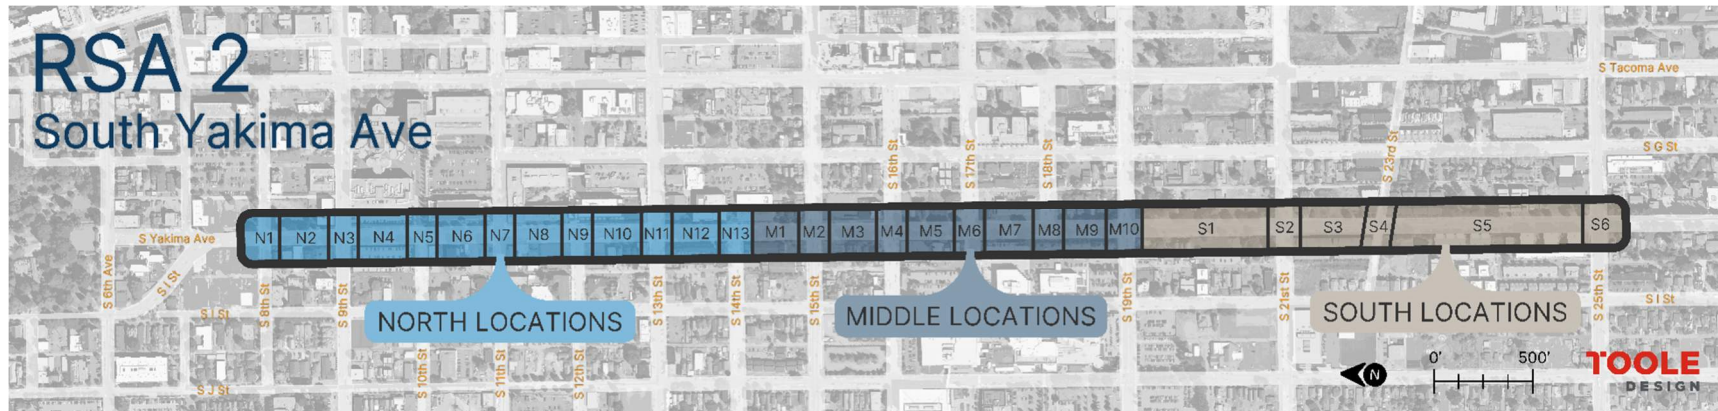
CORRIDOR-WIDE: SOUTH YAKIMA AVE FROM S 8TH ST TO S 25TH ST

LOCATION CODE	POTENTIAL IMPROVEMENTS FOR CONSIDERATION	TIMEFRAME			COST	CMF*	LEAD
		NEAR	INT.	LONG			
South Yakima Street between S 8 th St and S 25 th St	Update all existing signals to use 12" signal heads with reflective backplates. Evaluate whether the signal span needs to be replaced as part of this upgrade.	✓			\$\$- \$\$\$\$	0.85	CoT
	Evaluate all street lighting	✓			\$\$	-	CoT
	Evaluate 4 to 3 lane reconfiguration		✓		\$\$\$	0.53	CoT
	Install pedestrian scale lighting			✓	\$\$\$\$	-	CoT
	Limb up all trees within the ROW to 8' on sidewalk side and 14' on street side	✓			\$	-	CoT
	Resurface roadway and refresh/replace thermoplastic pavement markings after evaluating 4 to 3 lane reconfiguration		✓		\$	0.887	CoT
	Install edgeline between outside travel lane and parking lane, or where parking is dropped, between the outside travel lane and shoulder	✓			\$	-	CoT
