THEA FOSS AND WHEELER-OSGOOD WATERWAYS REMEDIATION PROJECT

YEAR 0 BASELINE MONITORING

ANNUAL OPERATIONS, MAINTENANCE, AND MONITORING REPORT

FEBRUARY 28, 2007

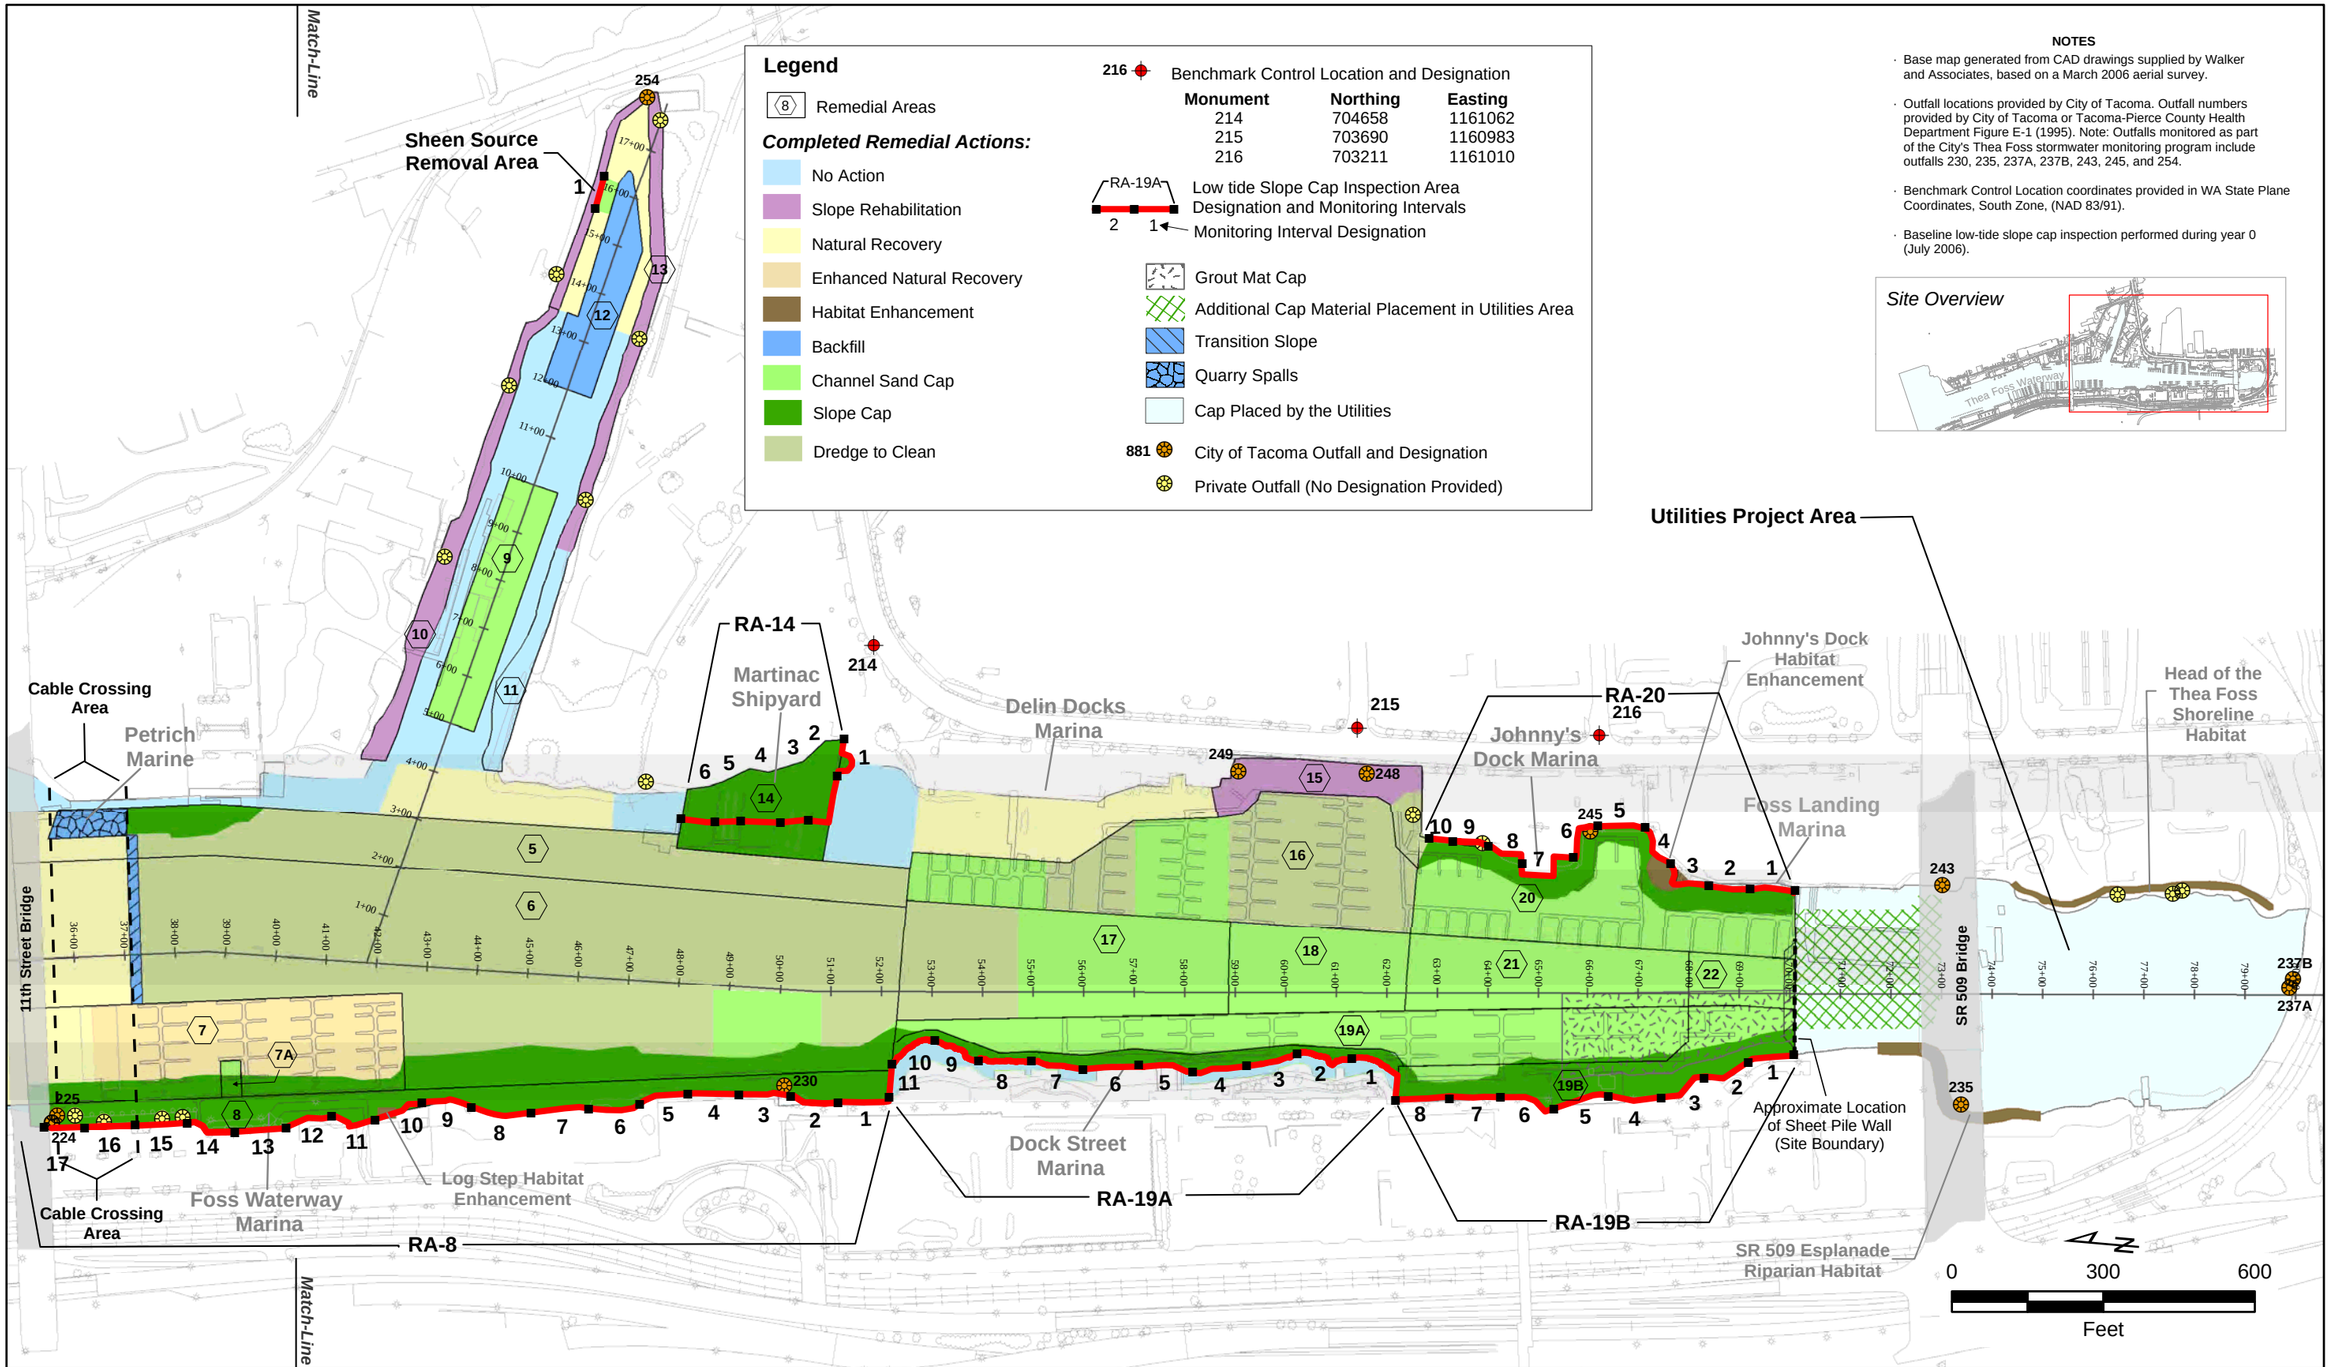
Figure 2-1 (Page 1 of 2)
Low Tide Slope Cap Inspection Monitoring Intervals

During outfall inspections, fabric was observed to be present at the surface of the capped area south and adjacent to Outfall 230. Additionally, the armoring of the outfall apron appeared to have settled or moved down slope. The fabric and apparent settlement of outfall apron armoring were not observed during the low tide slope cap inspection of monitoring interval 2 in RA 8 (i.e., the location of Outfall 230) performed in July 2006 (Figure 2-1). Source control staff informed the Foss O&M team of this issue.

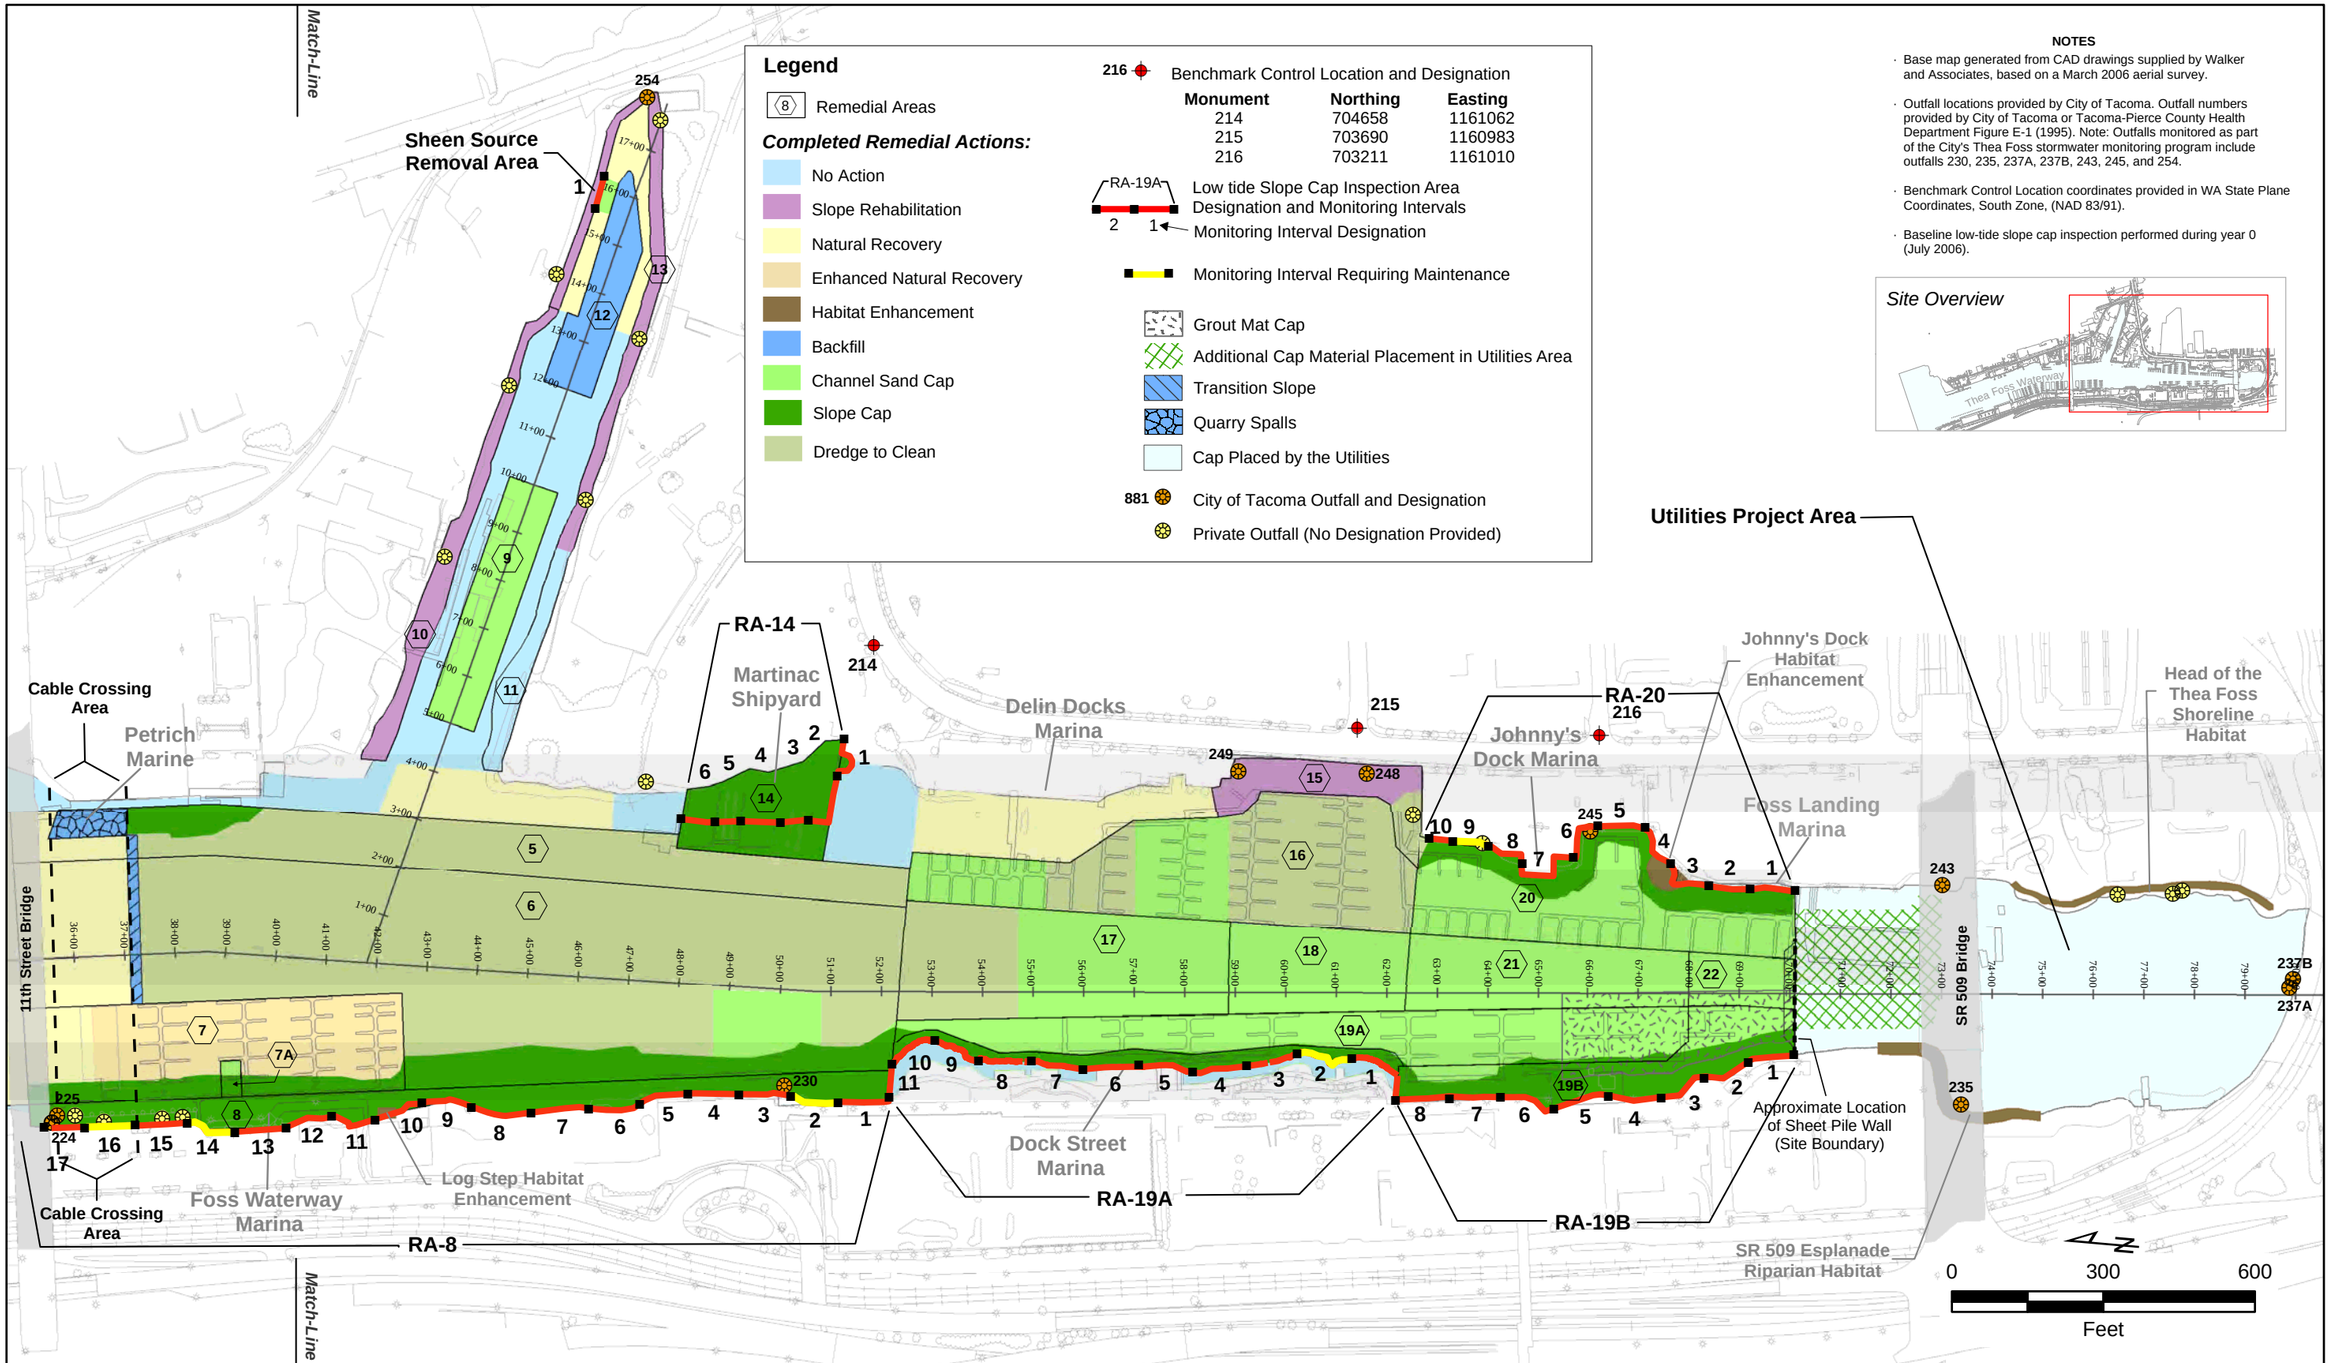
Figure 2-2 (Page 1 of 2)
Slope Areas Requiring Maintenance

A supplemental low tide inspection was performed by the Foss O&M team at Outfall 230 on January 17, 2007, to further evaluate the integrity of the slope cap and outfall apron. The fabric blanket was observed at the slope cap surface during the supplemental inspection. Additionally, concrete debris was observed at the slope cap surface up to 12 feet south of Outfall 230. The armoring for the apron in front of Outfall 230 also appeared to have settled or moved down slope. The field notes and photographs from the supplemental inspection of Outfall 230 are provided in Attachment A-3 in Appendix A. Table 2-1 and Figure 2-2 include this slope area as an area requiring maintenance.

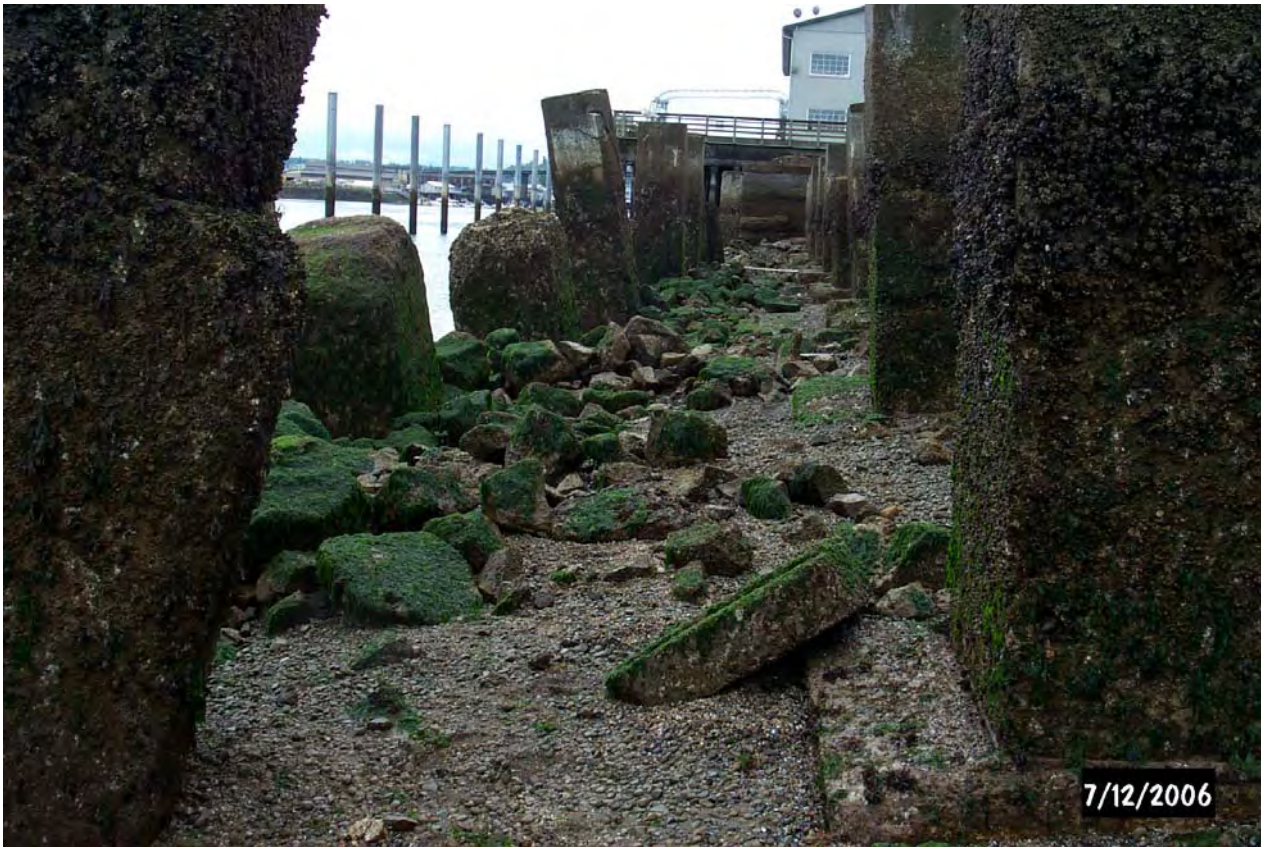
① Concrete monoliths throughout interval
Note: A photopoint was take @ 50Ft of the habitat mix bench. It was taken on the slope

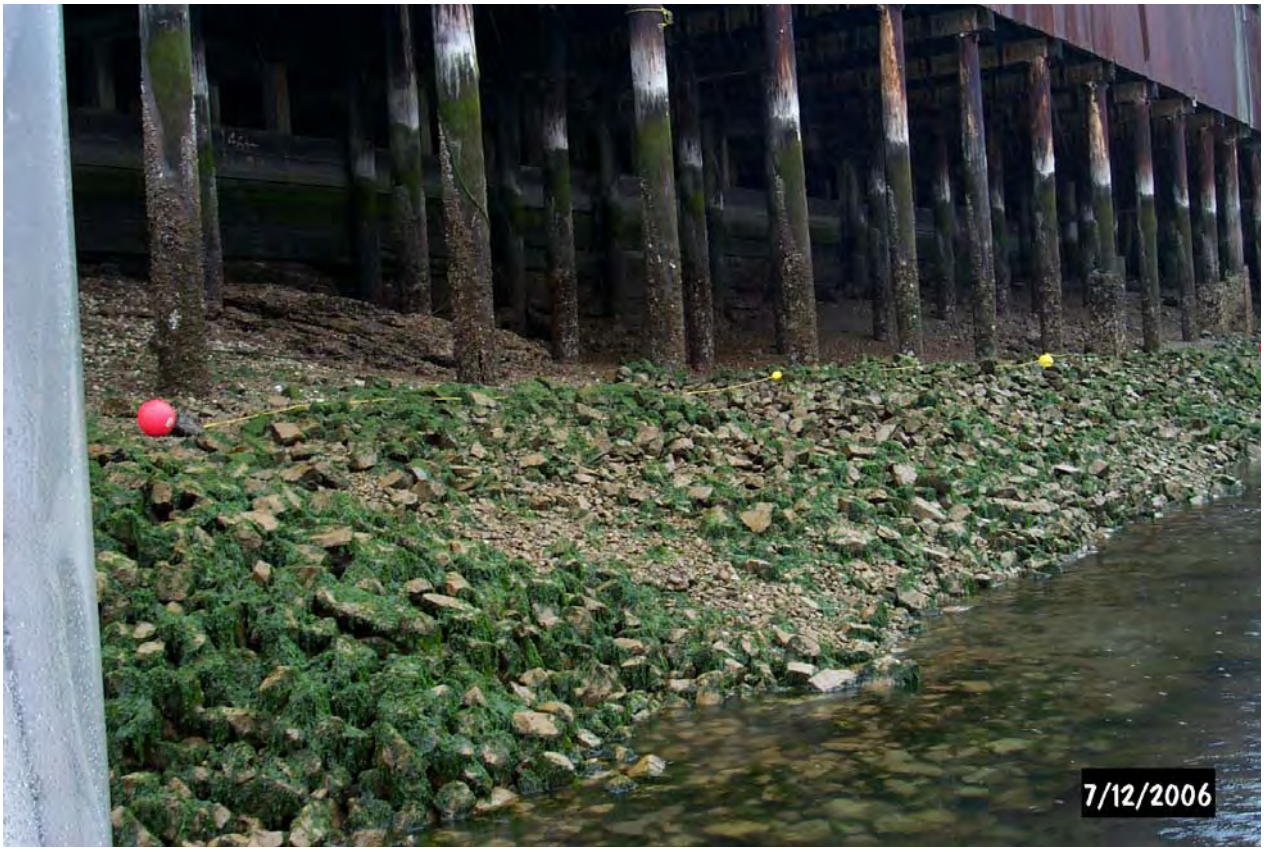
① Concrete run off
② Note: Bulkhead on upper slope above habitat mix
③ 2 sheets of metal debris

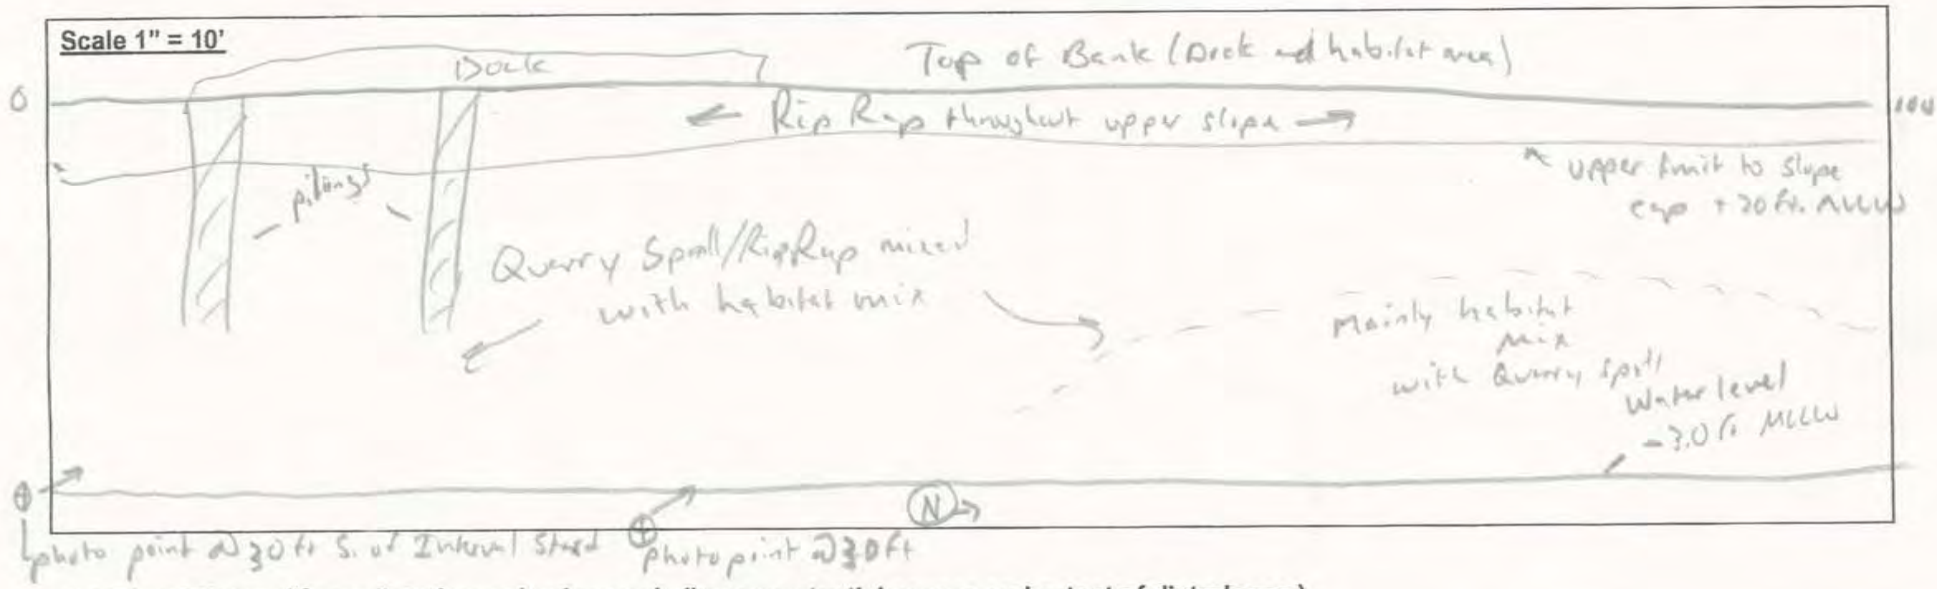
Note! Fibrous "mat" found on habitat mix. This is not accretion

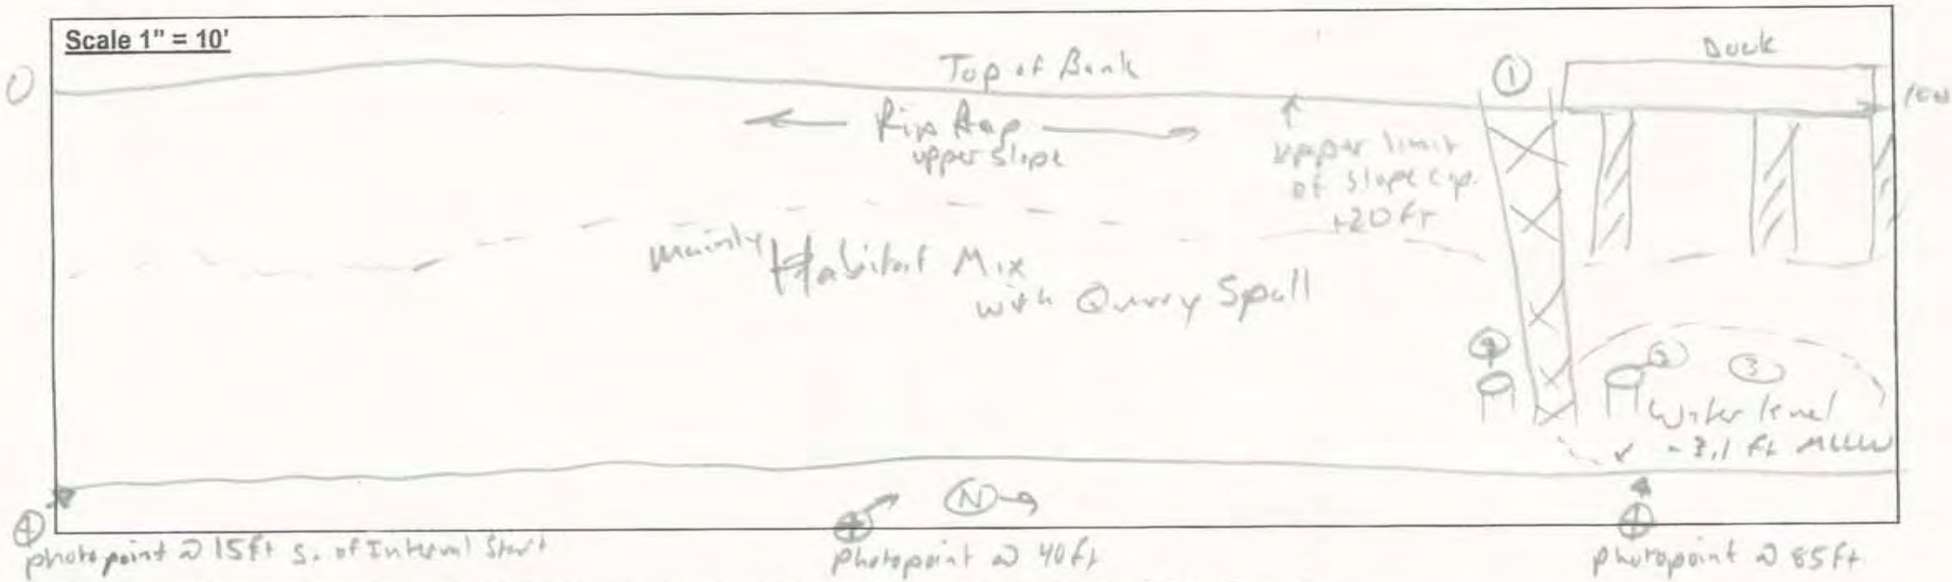
(1) Walkway from Top of Bank to Dock
(2) old broken pilings
(3) Possible sediment accretion

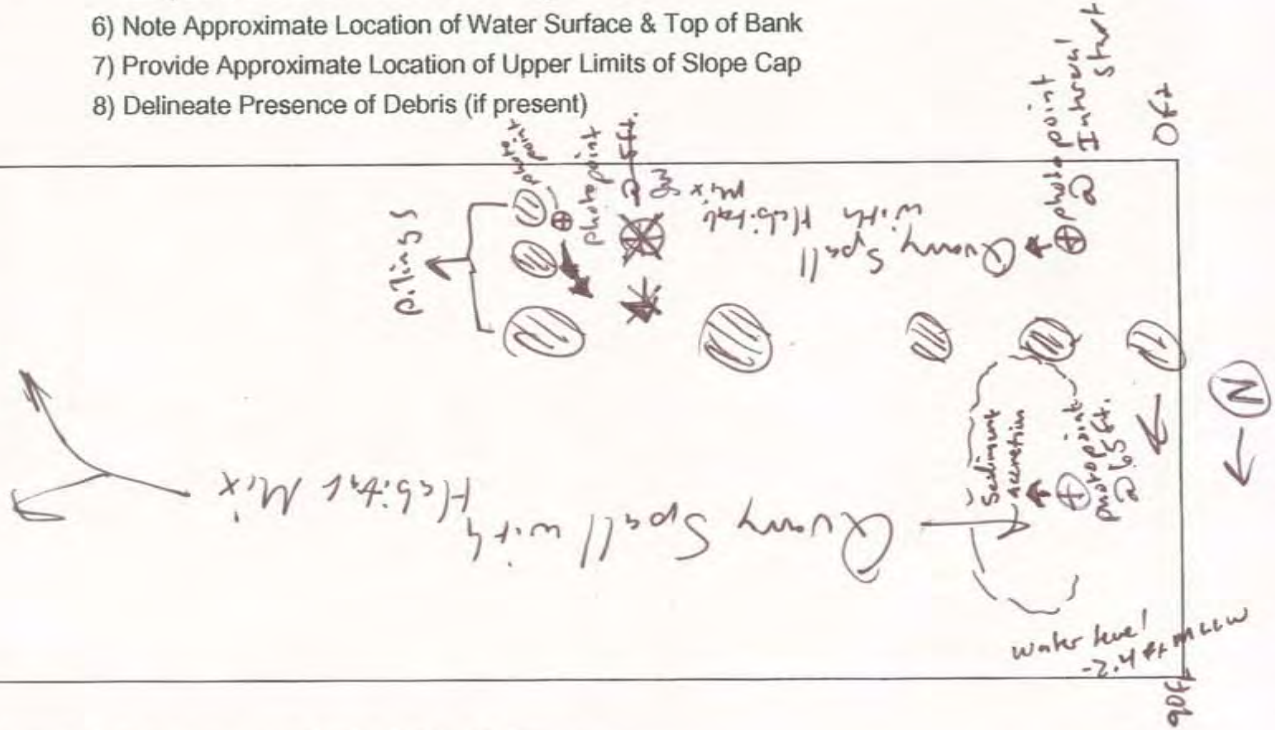
Monitoring Interval: RA14-4 (Wharf 1)

Note: Interval is under a wharf. All pilings are not shown. Mainly Quarry Spall with habitat mix

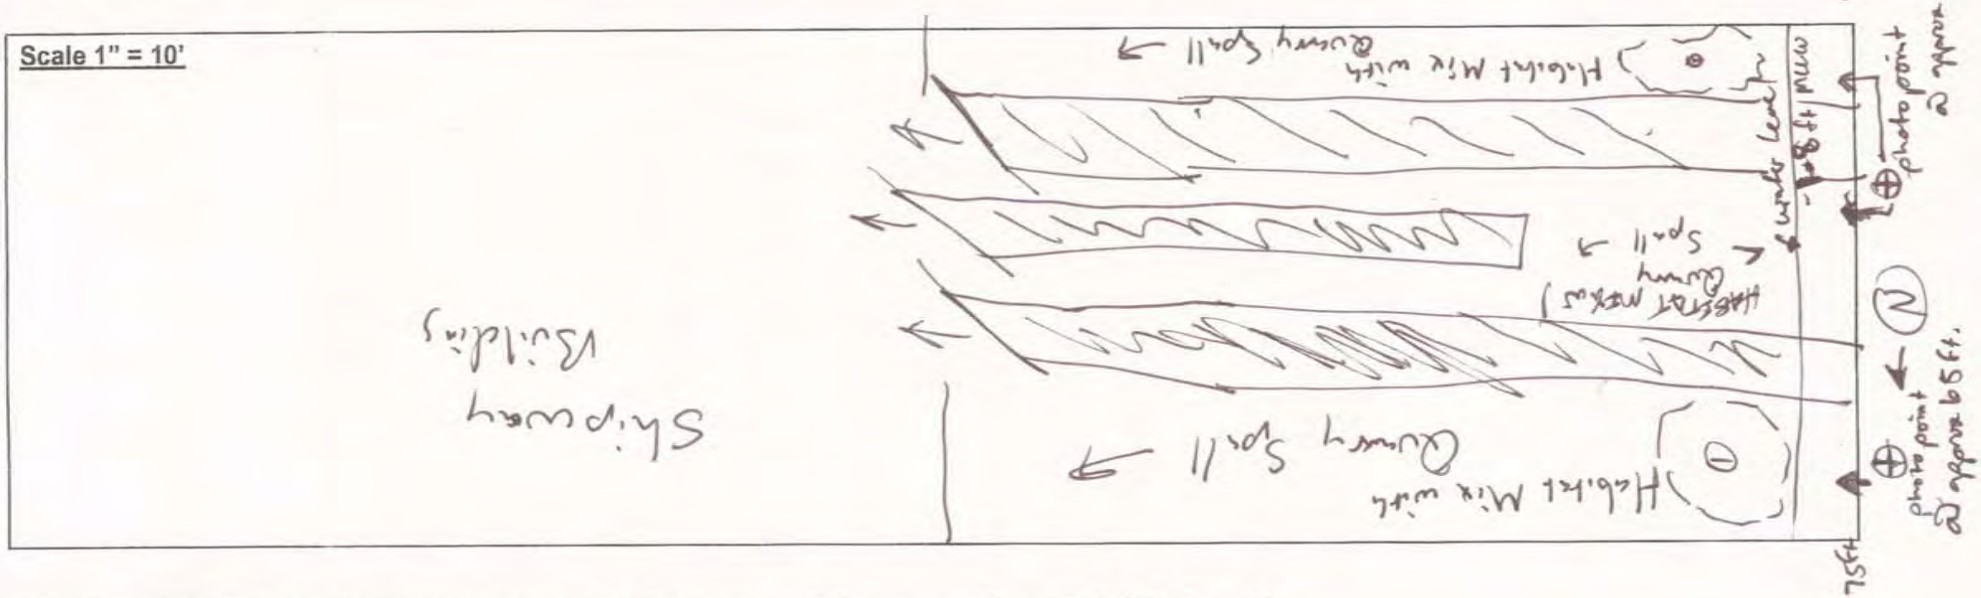
Monitoring Interval: RA14-5 (Shipyard North)

Shipyard Buildings
Heavy Spall
Heavy Spall
Heavy Spall

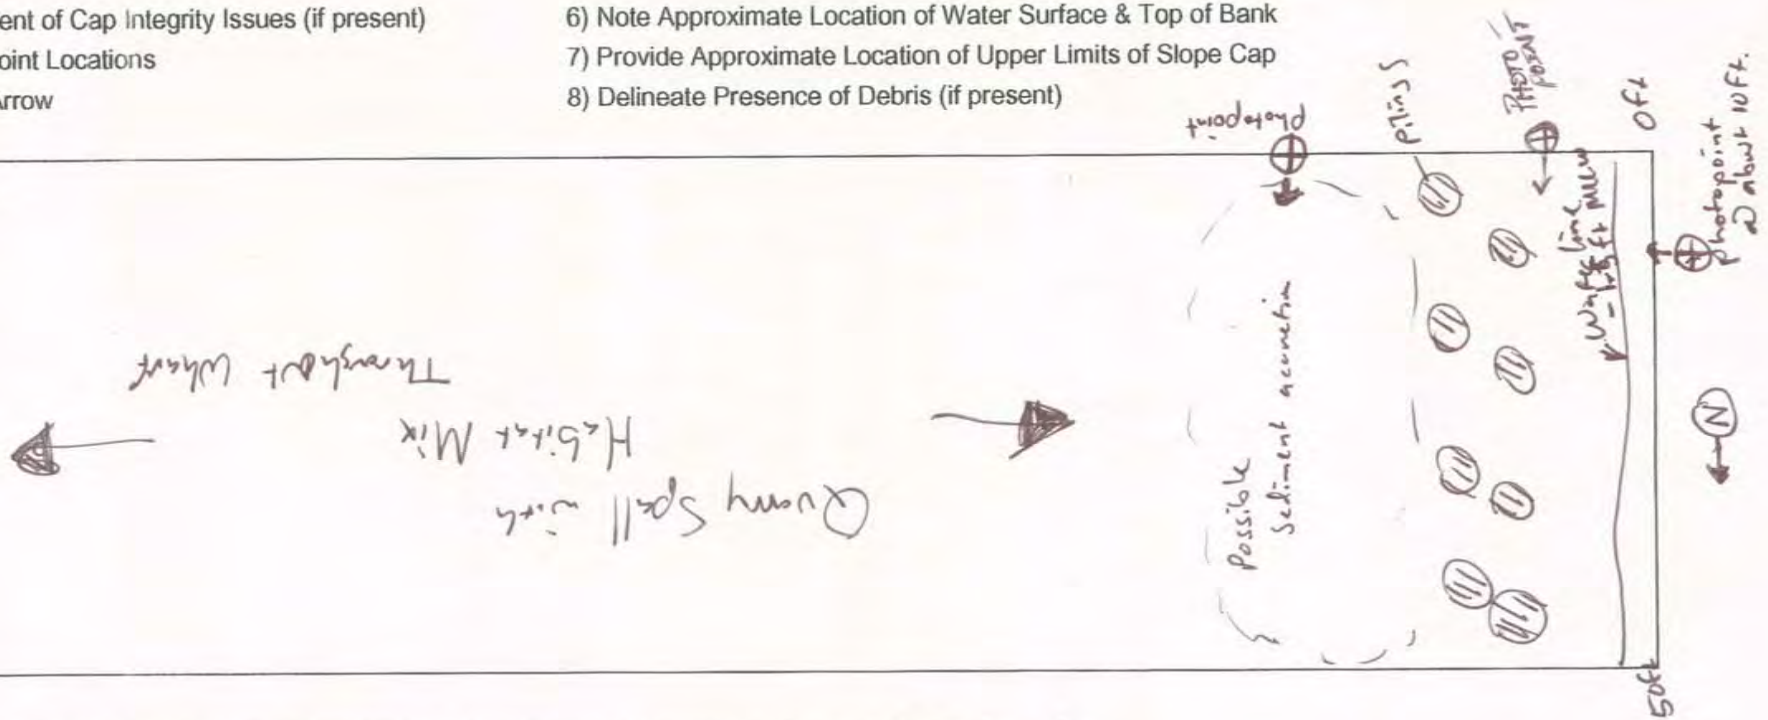
Monitoring Interval: RA14-6 (Wharf 3)

Note: Interval is underneath a Wharf, Mainly Quarry Spall with habitat mix. Some sediment accretion towards the water line

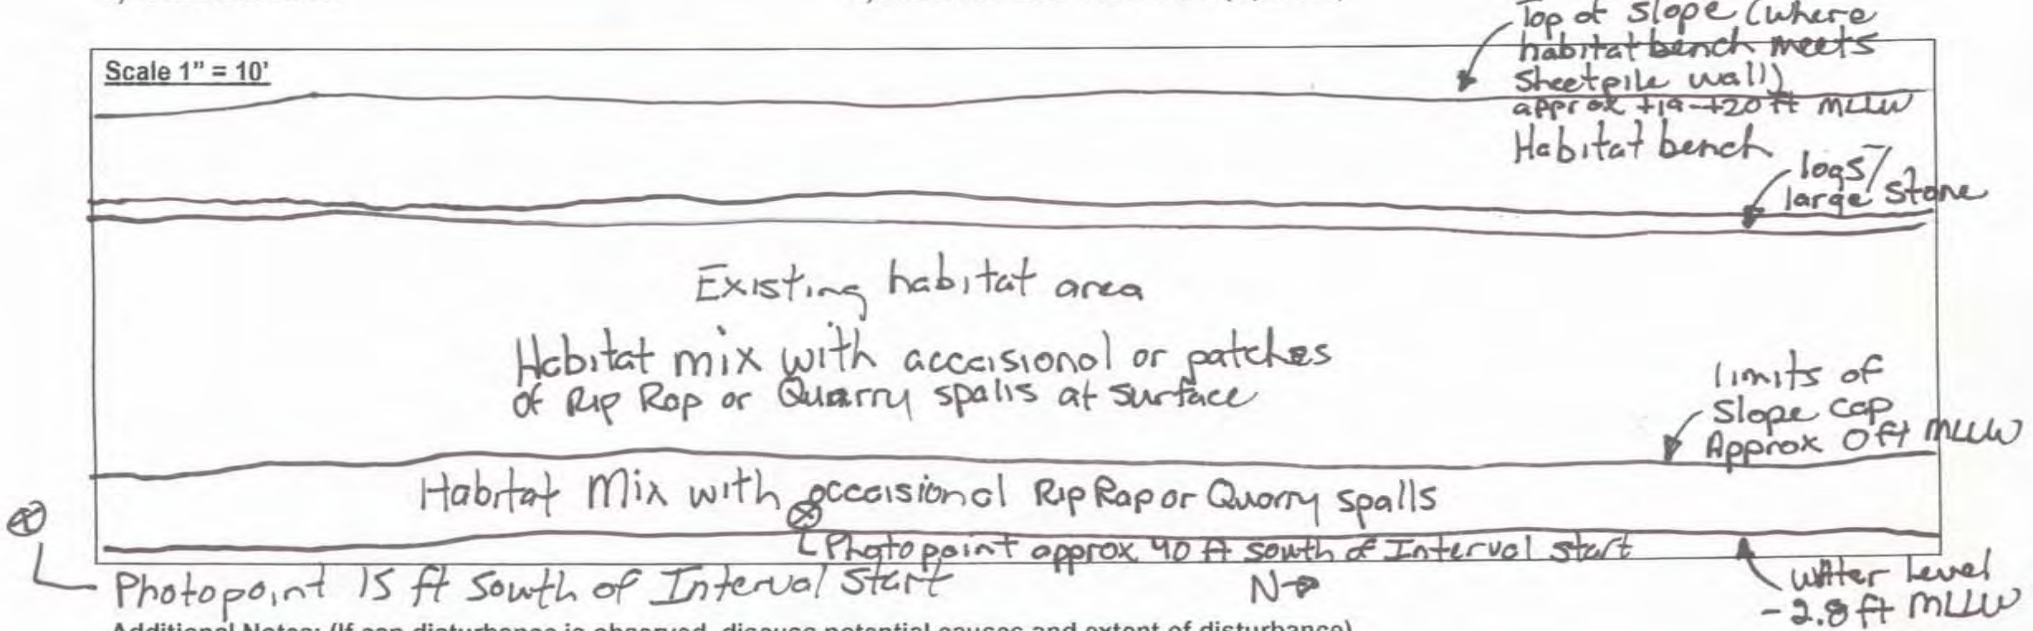
No observed difference or transition from existing habitat area to Slope Cap

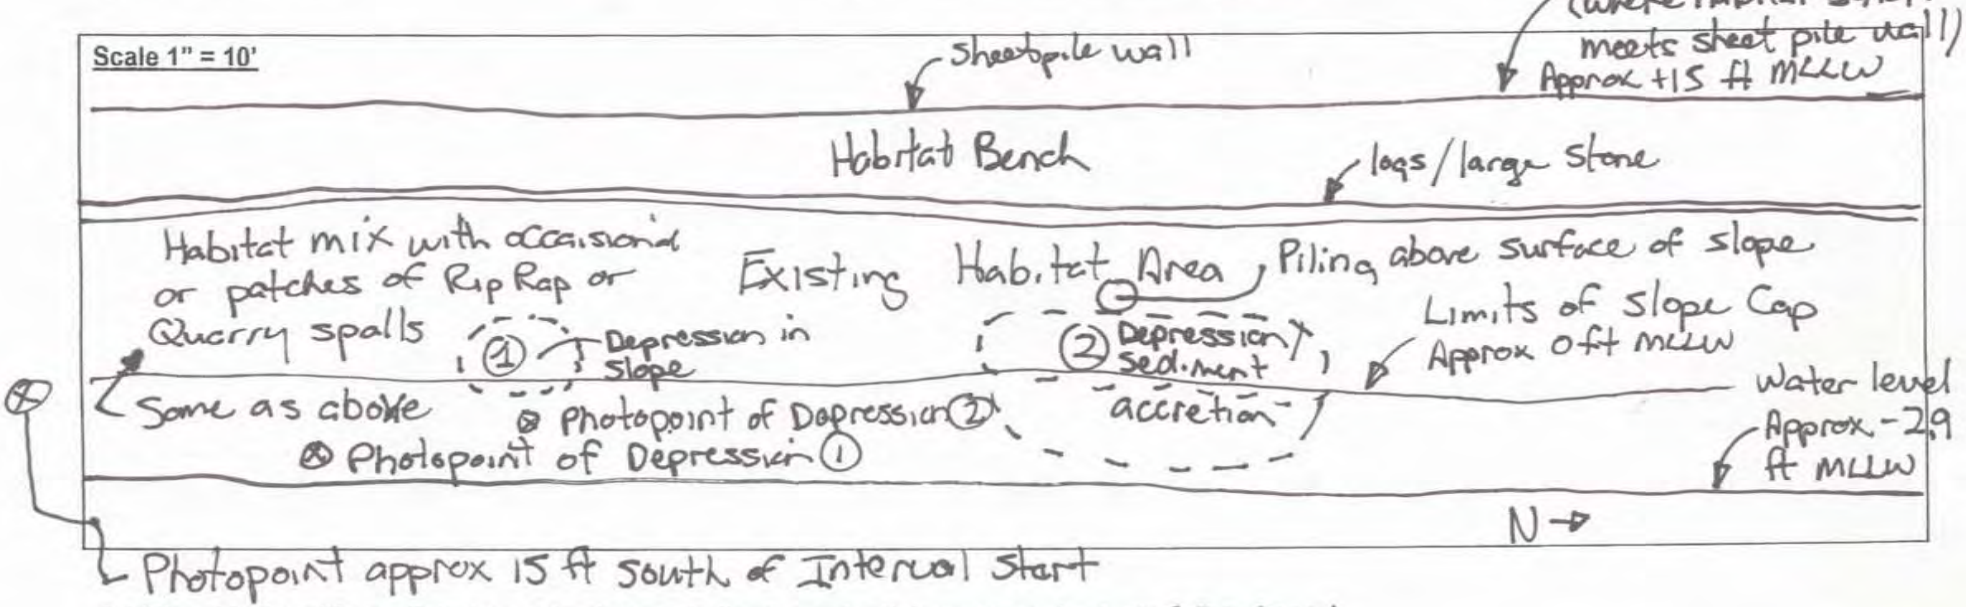
① Depression in slope at approx upper limits of slope cap (dimension 5 ft wide)
② Depression in slope at between approx 55 to 75 ft South of interval start
Note: No observed difference or transition between slope cap and existing habitat

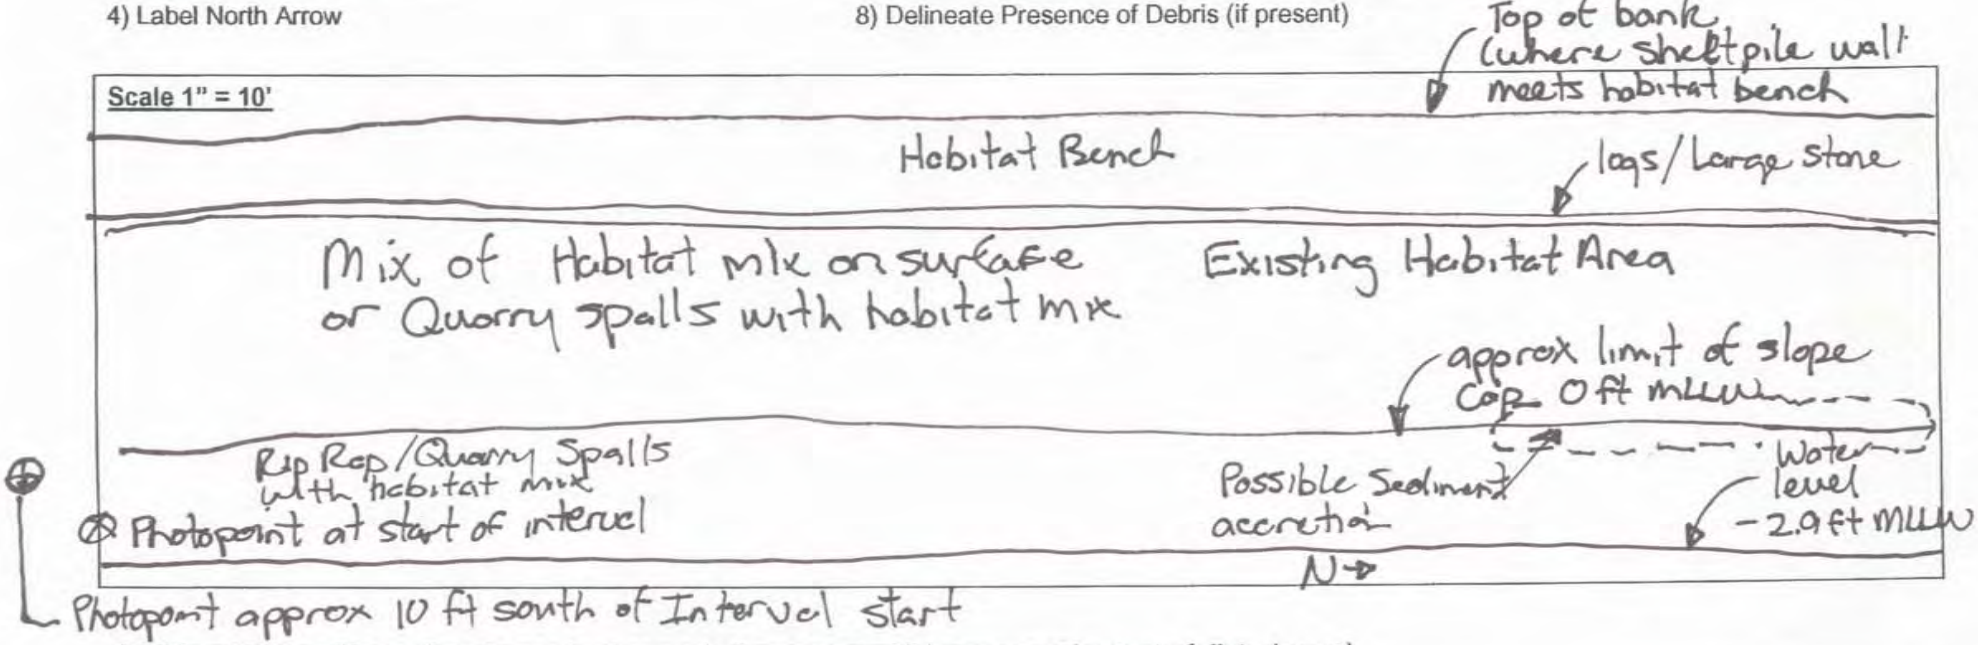
Note: No observed transition of difference between slope cap and existing habitat

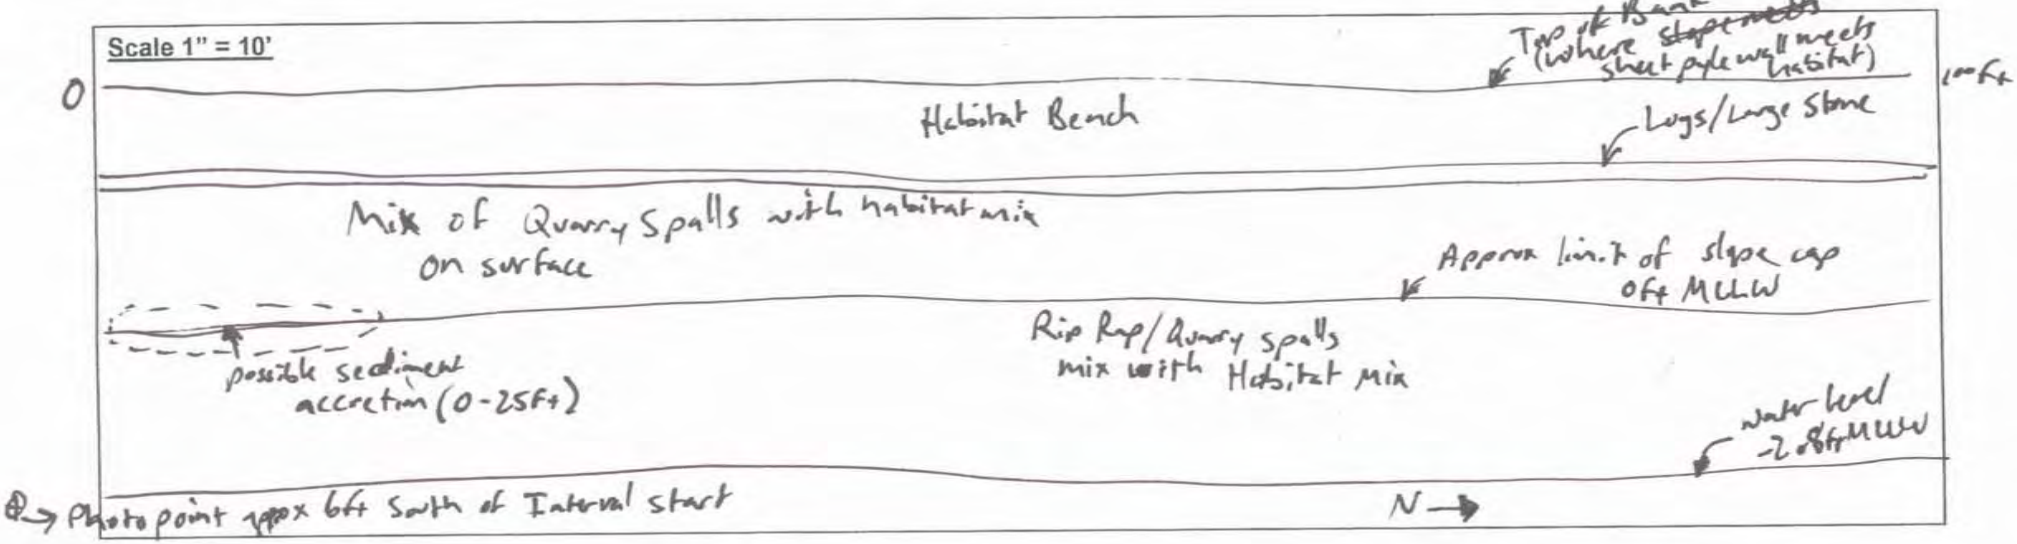
Note: No observed transition between slope cap and existing habitat

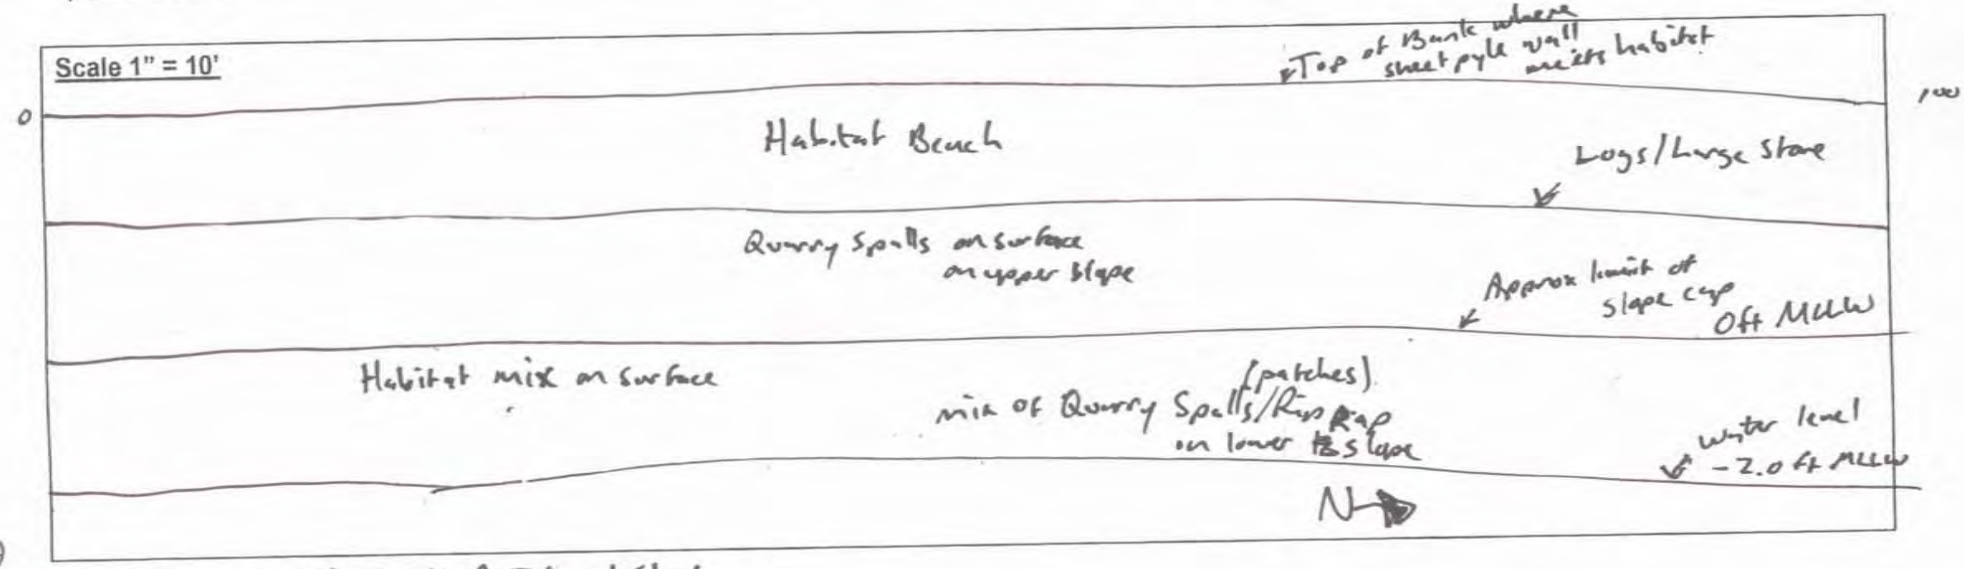
Note: No observed transition between slope cap and existing habitat

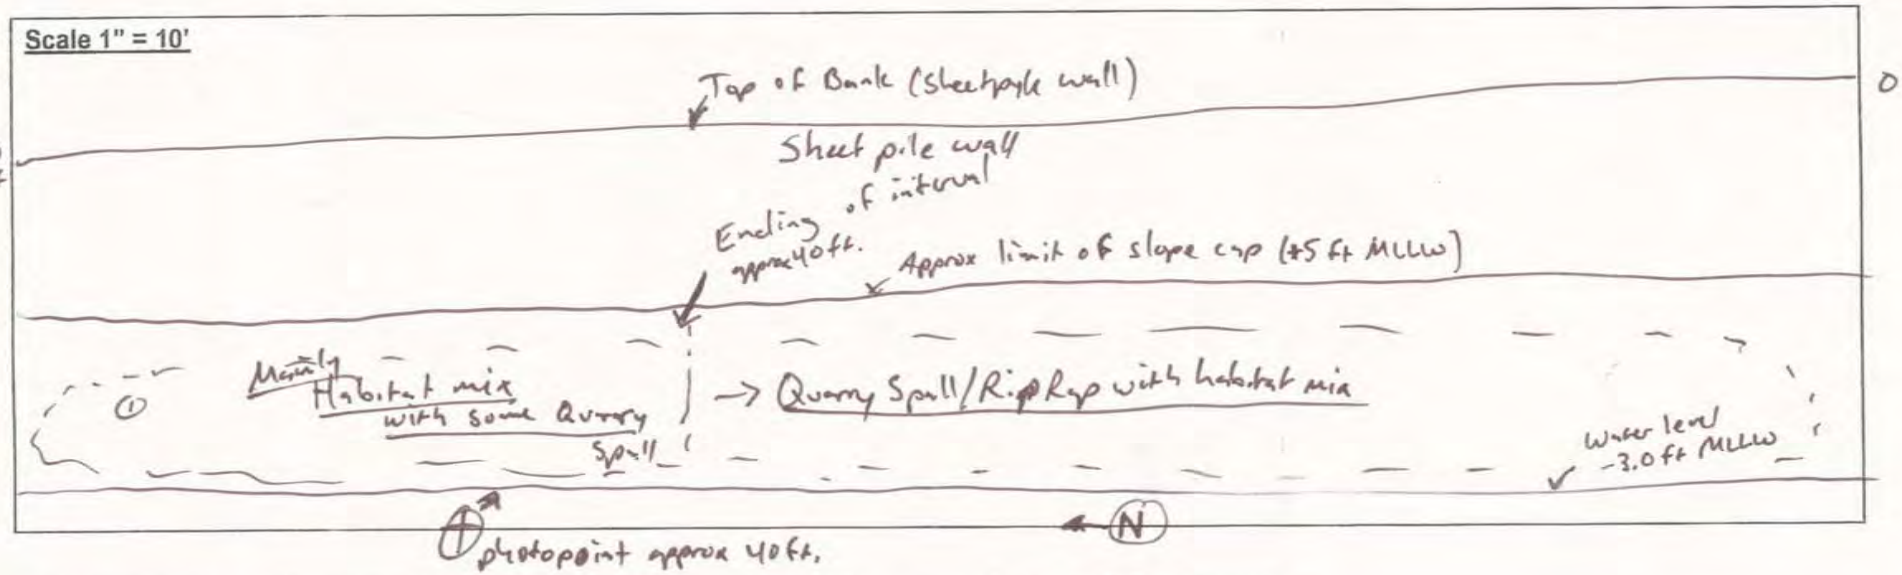
- Photos taken approx midway down shoreline slope north and adjacent to seep source area (i.e., slope is north and adjacent to Seep Source Removal Area).
- Photo #3 shows transect line with bouy stretched out into waterway to identify width of transect (i.e., red bouy is out to south edge of sheen source area (Width is approx 20 ft)

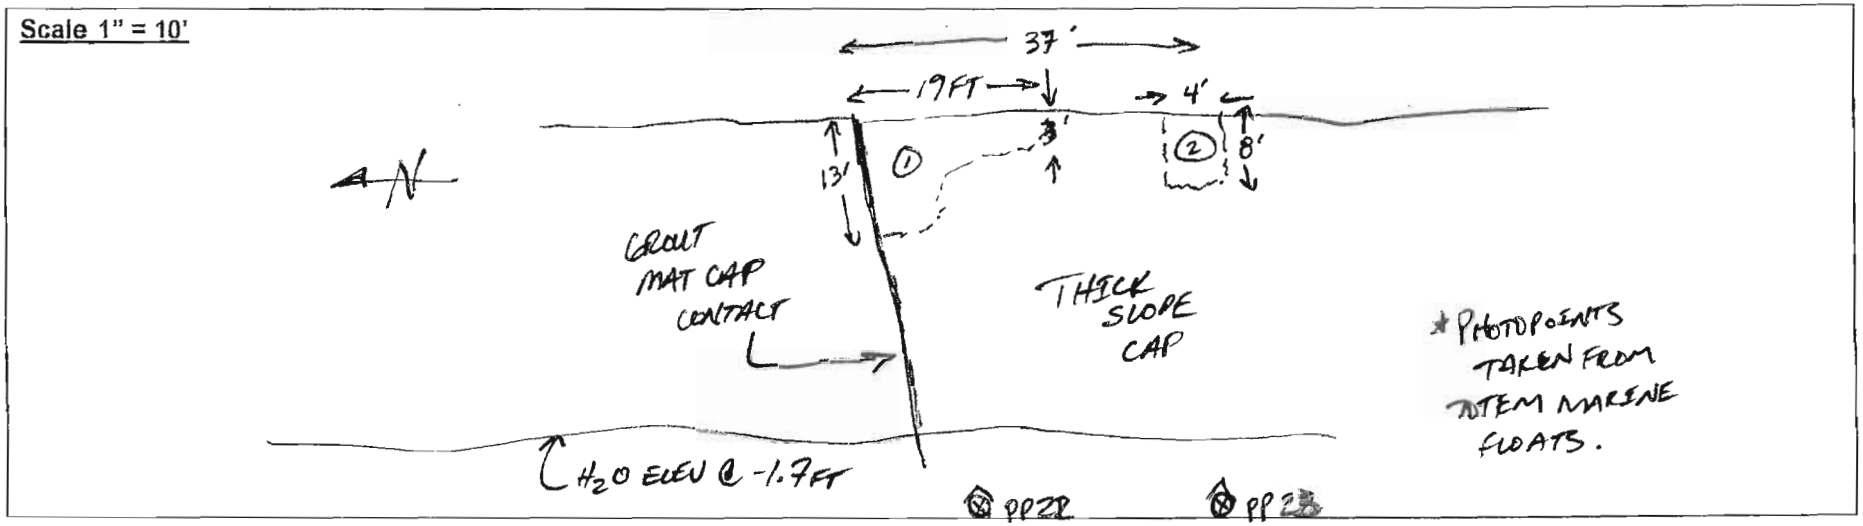
Monitoring Interval: RA 3-1 & RA3-2

1238 - TIDE @ ELEV -1.7FT. ① & ② TWO AREAS WHERE THICK SLOPE CAP WAS PUT DOWN THIN OR HAS MOVED TO EXPOSE UNDERLYING GEOTEXTILE FABRIC. SOME HABITAT MIX OBSERVED IN ROCK VOIDS. AREAS OF EXPOSED GEOTEXTILE AT APPROX ELEVATIONS +13-FT TO +16FT.
