THEA FOSS AND WHEELER-OSGOOD WATERWAYS REMEDIATION PROJECT

YEAR 0 BASELINE MONITORING

ANNUAL OPERATIONS, MAINTENANCE, AND MONITORING REPORT

FEBRUARY 28, 2007

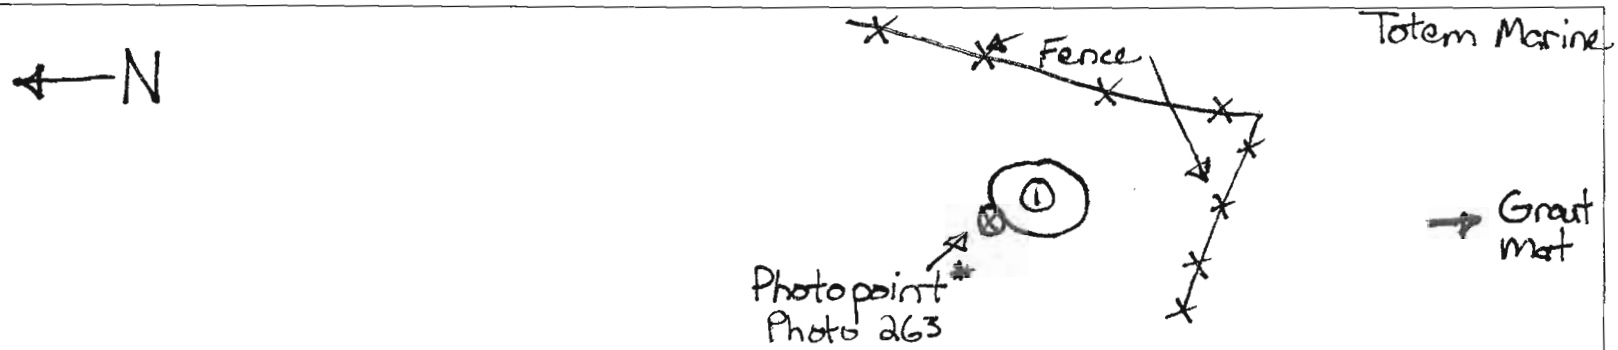
Monitoring Interval: RA3-3

1 Mass of metal and slag - Solidified mass appears to be predominantly iron based (i.e., red/rust)
* Additional photo taken at close proximity to show nature of exposed Material

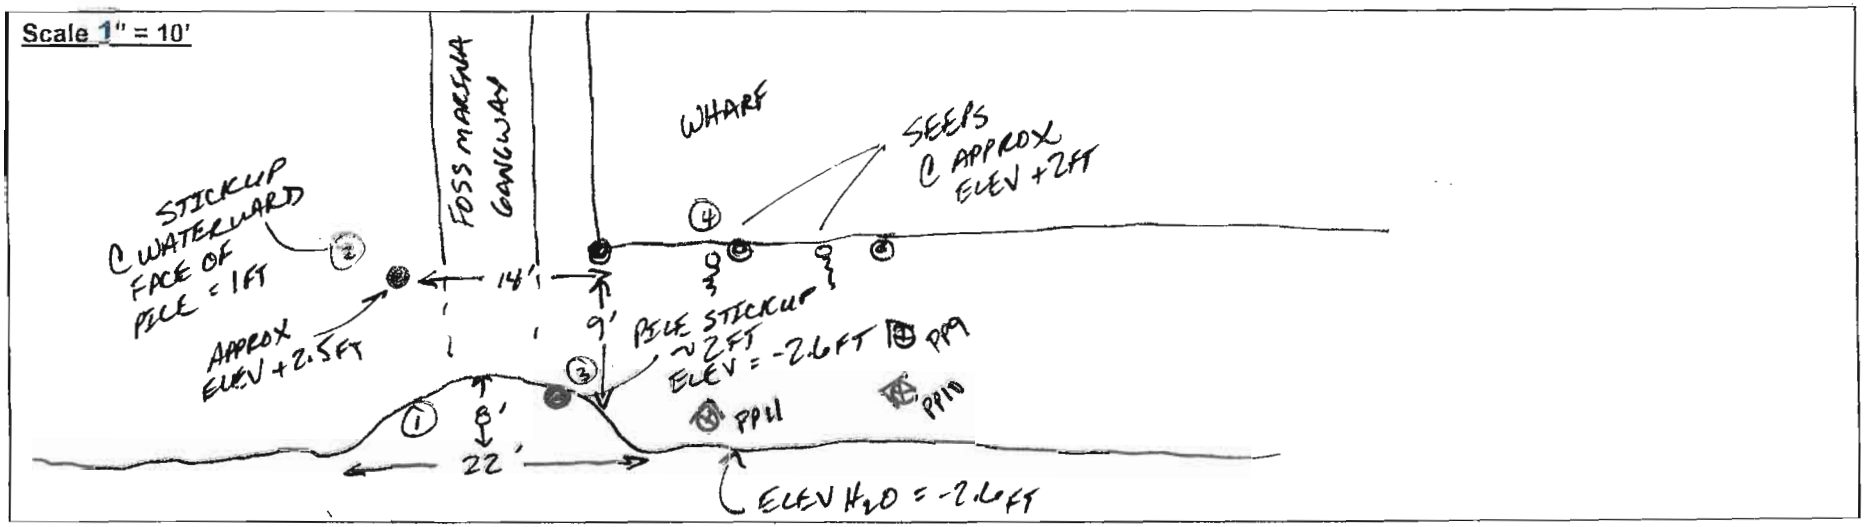
1107 - TIDE ELEV -2.6 FT. ① CUT BACK INTO SLOPE TO ALLOW GANGWAY & PIER ACCESS. ② & ③ TIMBER PILING. ④ WATER SEEPS OBSERVED @ FACE OF FRONT OF WHARF PILING... MODERATE SEEPAGE OBSERVED. BOATS OBSERVED GROUNDING ON SAND-SIDE OF MARINA FLOATS

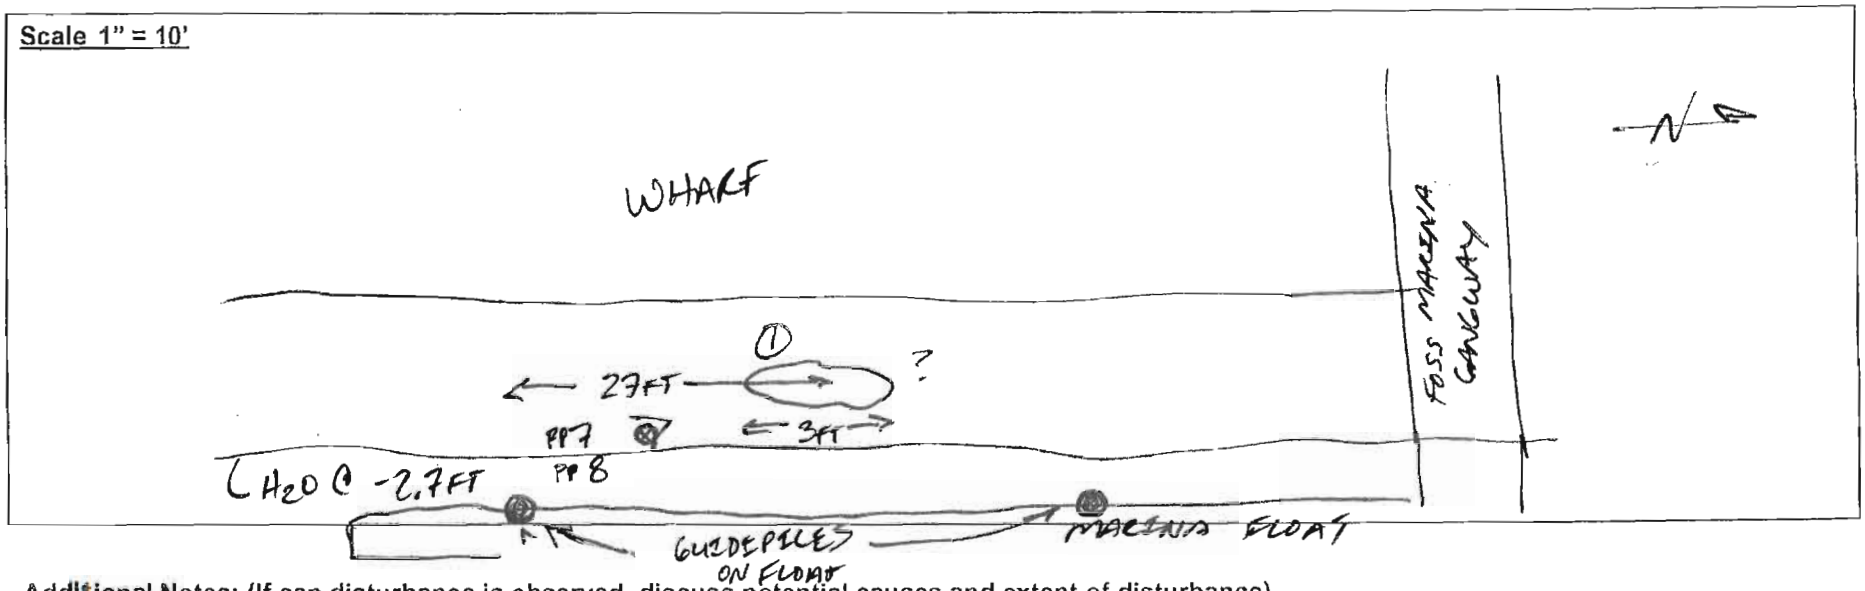
Monitoring Interval: RAB-16

H2O - TIDE ELEV. @ -2.7'. ① EXPOSED ORANGE MATERIAL, POSSIBLE DEBRIS BENEATH SLOPE CAP, EXPOSED AREA ~ 3FT LONG @ APPROX. ELEV +2FT. SLOPE CAP VERY STEEP HERE (CONFIRED W/ QUARRY SPALL & RIPRAP HAB. MIX).

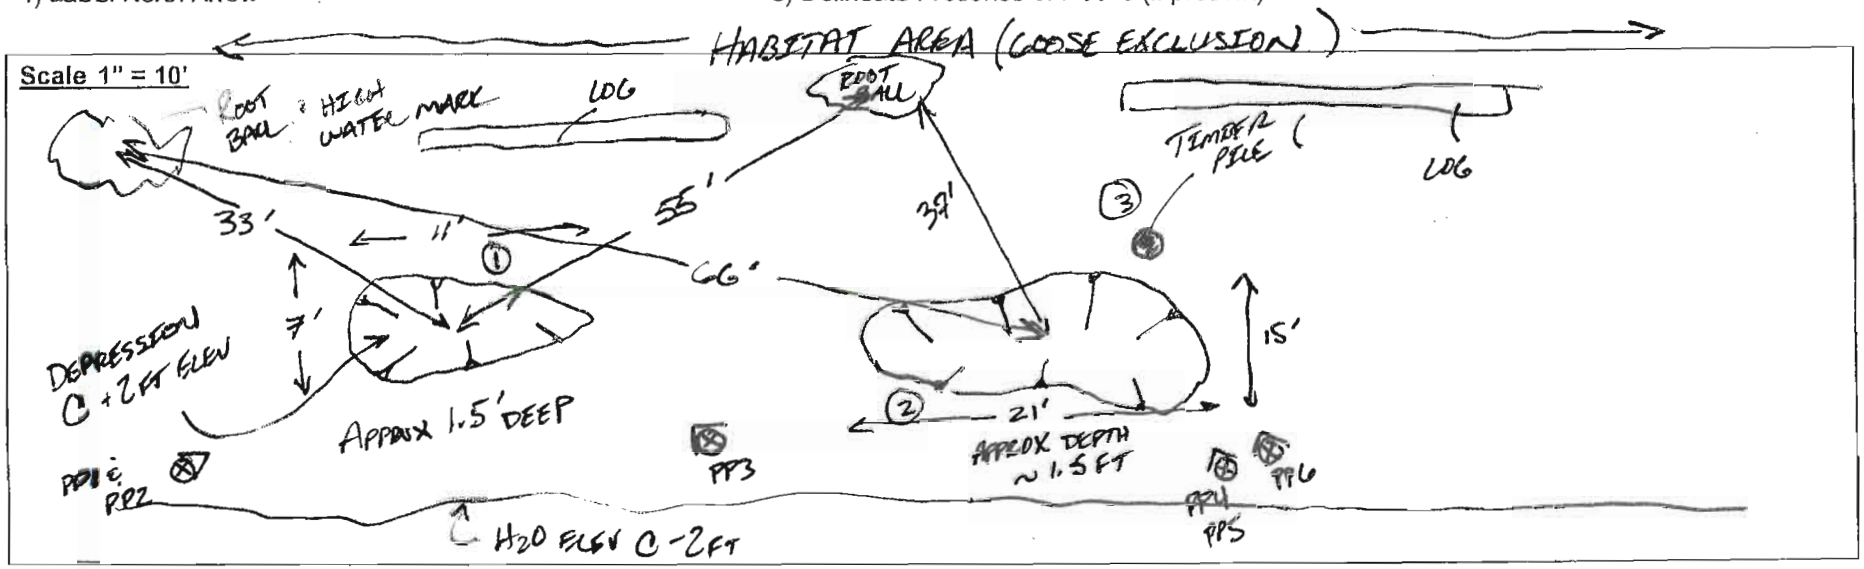
1034 - TIDE @ -2 FT MLLW. TWO SHALLOW DEPRESSIONS (① & ②) & ONE TIMBER PILE (③) ALONG TRANSECT. MEASUREMENTS FOR LOCATION TAKEN FROM ROOT BALL @ SOUTH END OF TRANSECT. BOTTOM OF ① FILLED W/HABITAT MIX & QUARRY SPALLS. BOTTOM OF ② FILLED W/HAB. MIX & FINE DARK SEDIMENT. PILE STICKUP ABOVE MUDLINE APPROX 1.5 FT @ WATERWARD FACE OF PILE

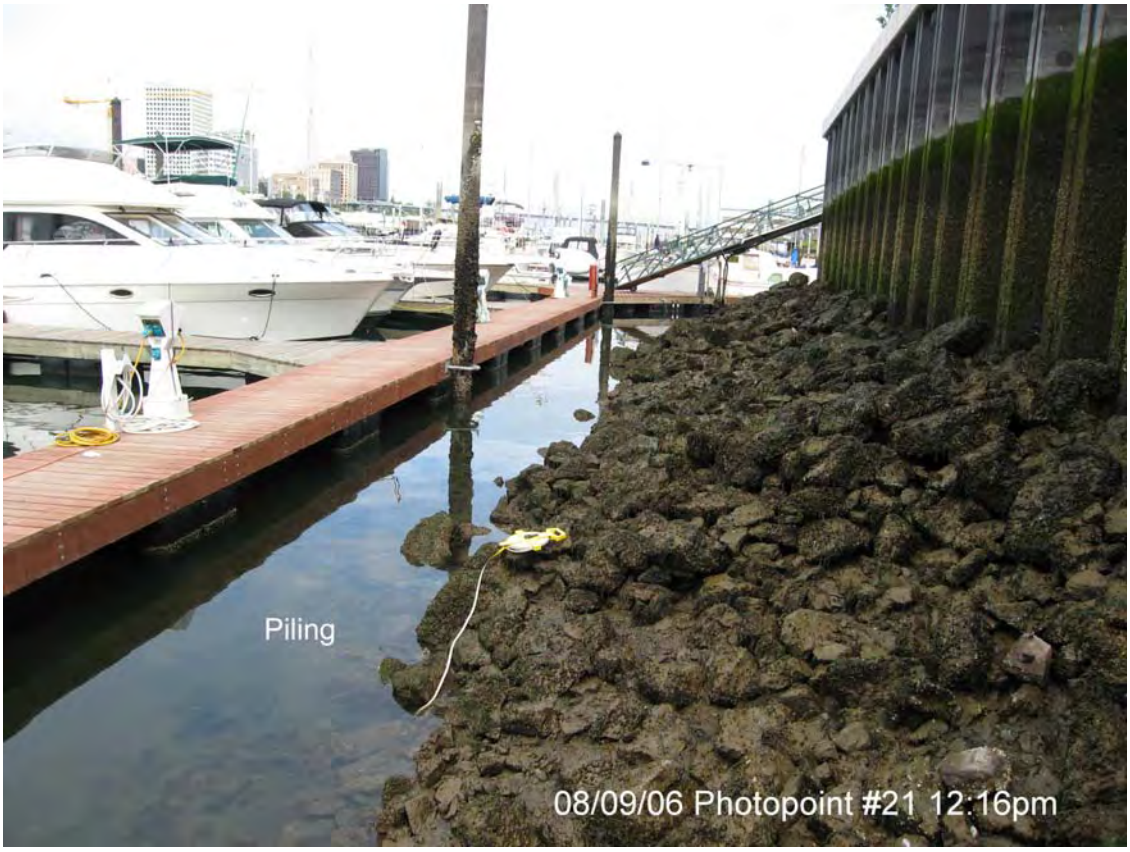
R15 - TIDE @ ELEV -2FT. ① SUBMERGED CUTOFF PILING PROTRUDING THROUGH RIP-RAP/HAB MIX CAP PILE @ APPROX. ELEV -2.5FT.

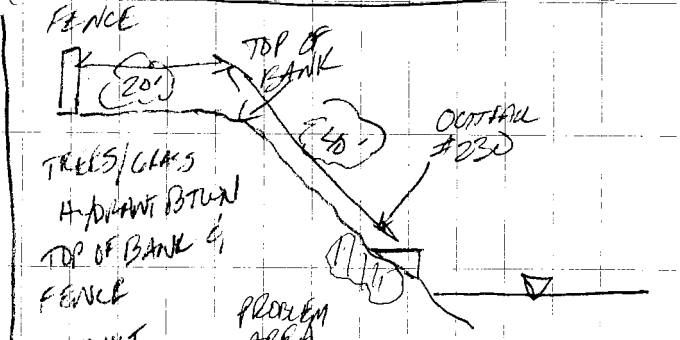
OUTFALL #230 - NEW SITE FROM LOW TIDE OUTFALL INSPECTION

- CONCRETE RUBBLE ~1/4 UP EDGE OUT OUTFALL
- EXTENDS ~12FT FROM EDGE OF OUTFALL
- NO EVIDENCE IN POST-LOW PHOTOS
- BLANKET SEEN IN PRE-LOW PHOTOS

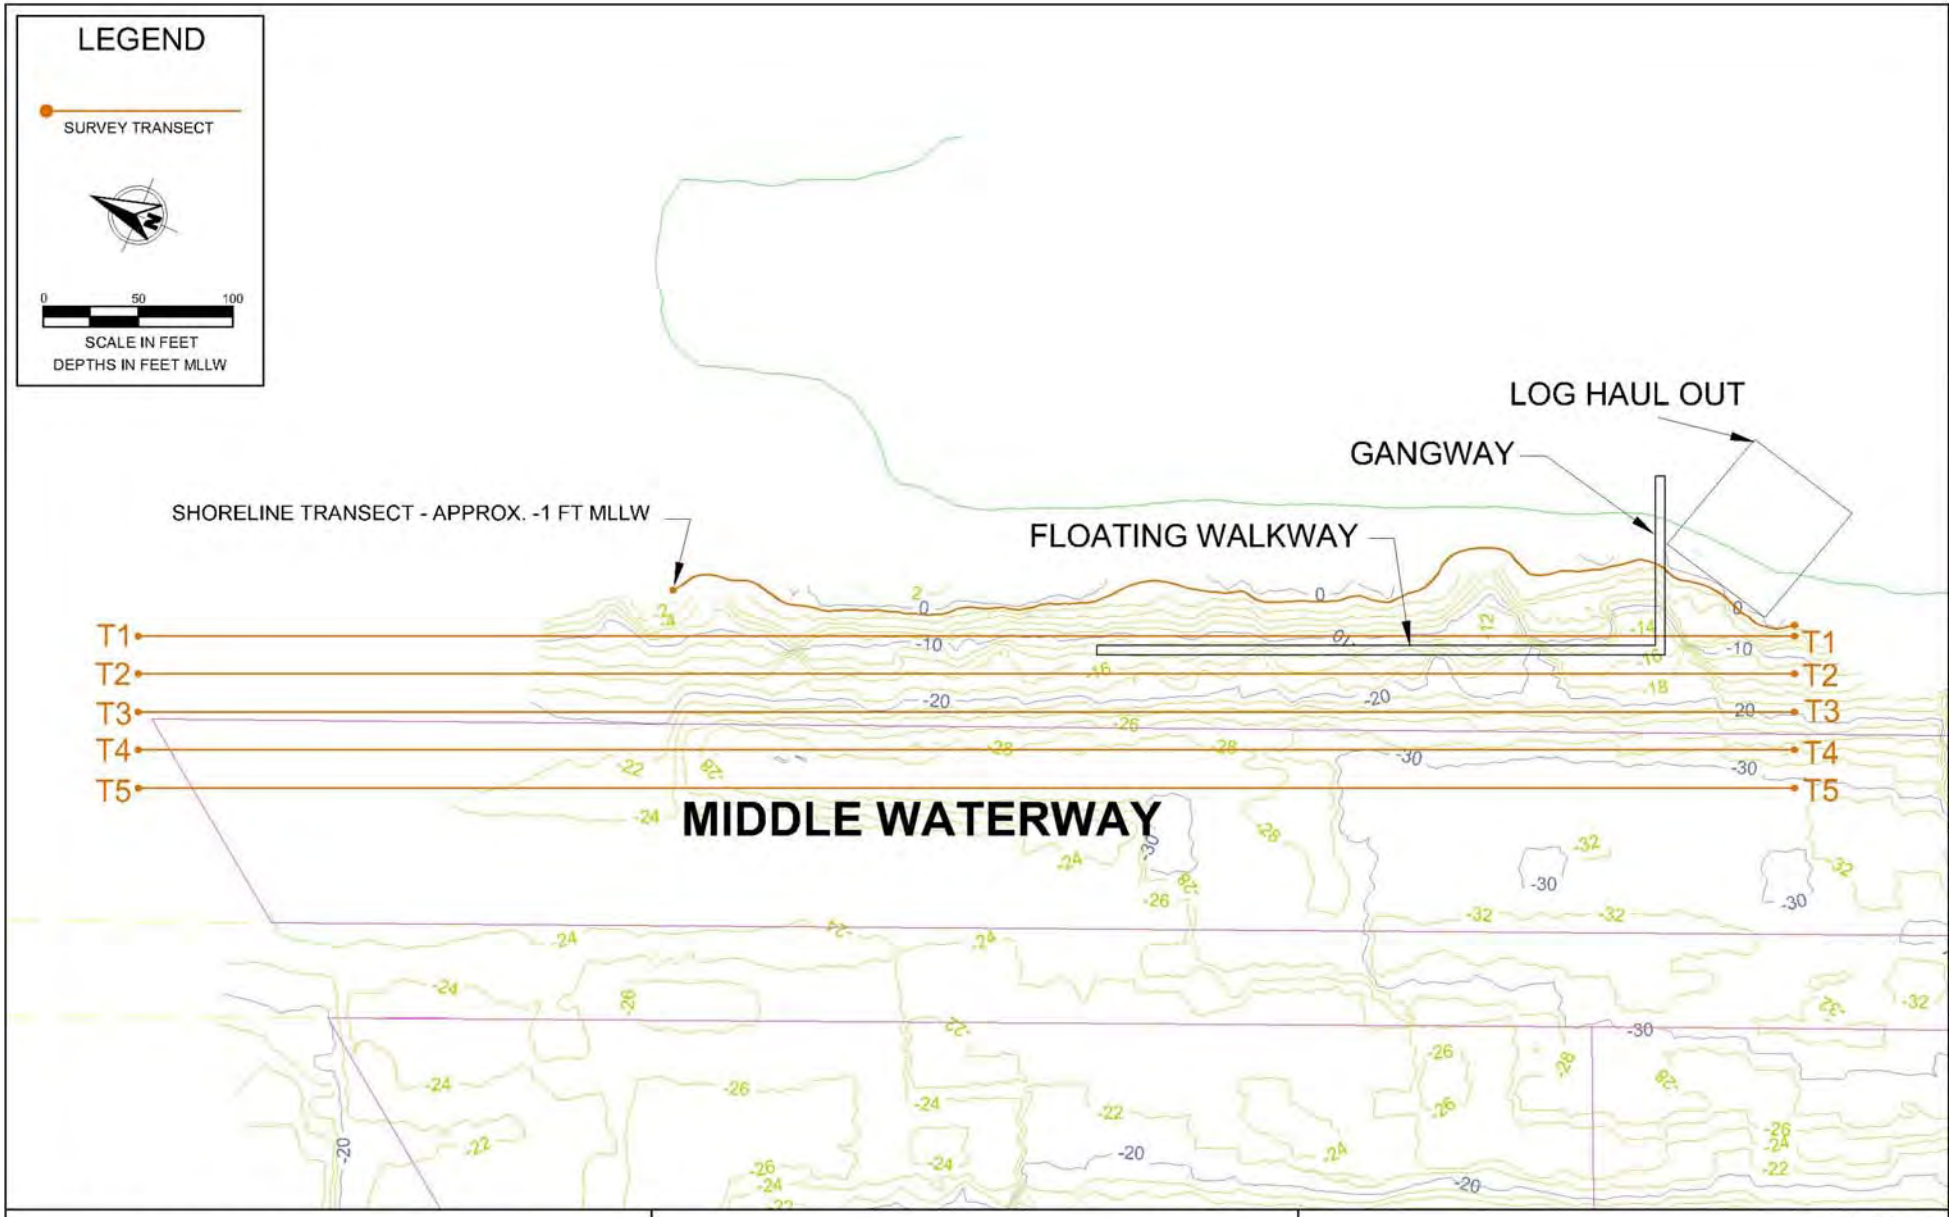
Wood debris was observed along all five transects (Photos 3 & 4). Generally, wood debris decreases away from shore, with significantly less wood (and other debris) on Transects 4 and 5. Wood debris included broken pile, pile stubs, processed wood waste, tree stumps, and bark. Dredge cuts were observed on Transects 1 and 3 where vertical walls left by the clamshell exposed thick areas of processed wood waste up to 50 ft in length. A large area of wood waste approximately 20 ft long by 10 ft wide and 2 ft deep was observed on Transect 2; another area extended from the end of the float to the 2nd pile further north on Transect 1. In this same area at least eight exposed pile stubs were observed. There was also one very large section of pier

decking immediately north of the last pile on this transect. At least 15-20 broken pile, from 3 ft to >12 ft long, were observed on Transects 1 to 3. Areas of bark up to 2 ft wide by 4 ft long were present but not common on Transects 1 to 3. Sparse wood debris was present on Transects 4 and 5. A number of tires also were observed in the survey area.

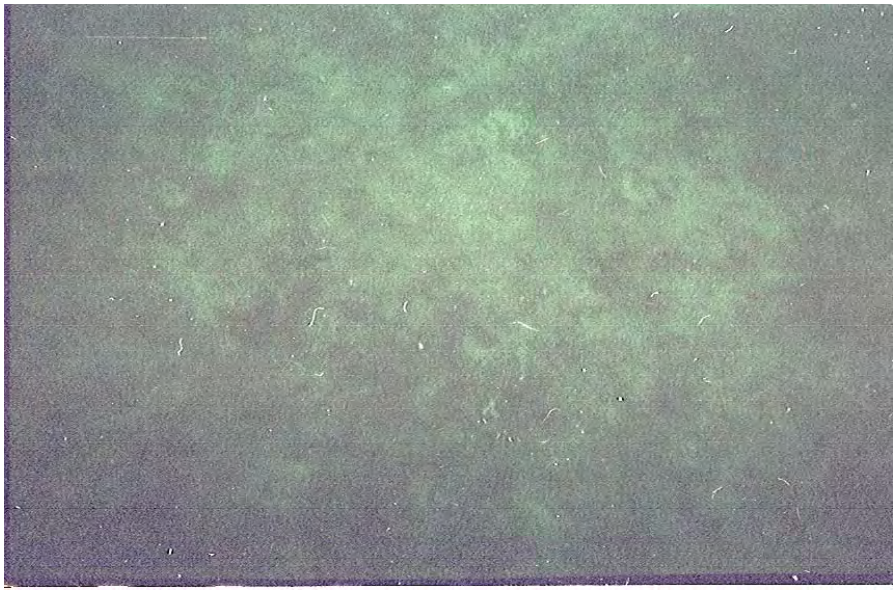
Photograph 1. Riprap and quarry spalls typical of Transects 1-3

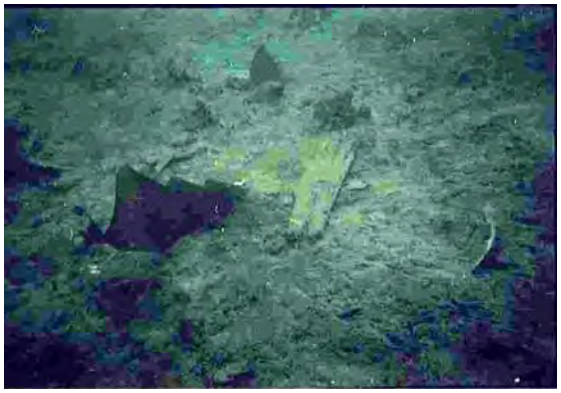
Photograph 3. Wood waste exposed by dredge cut.

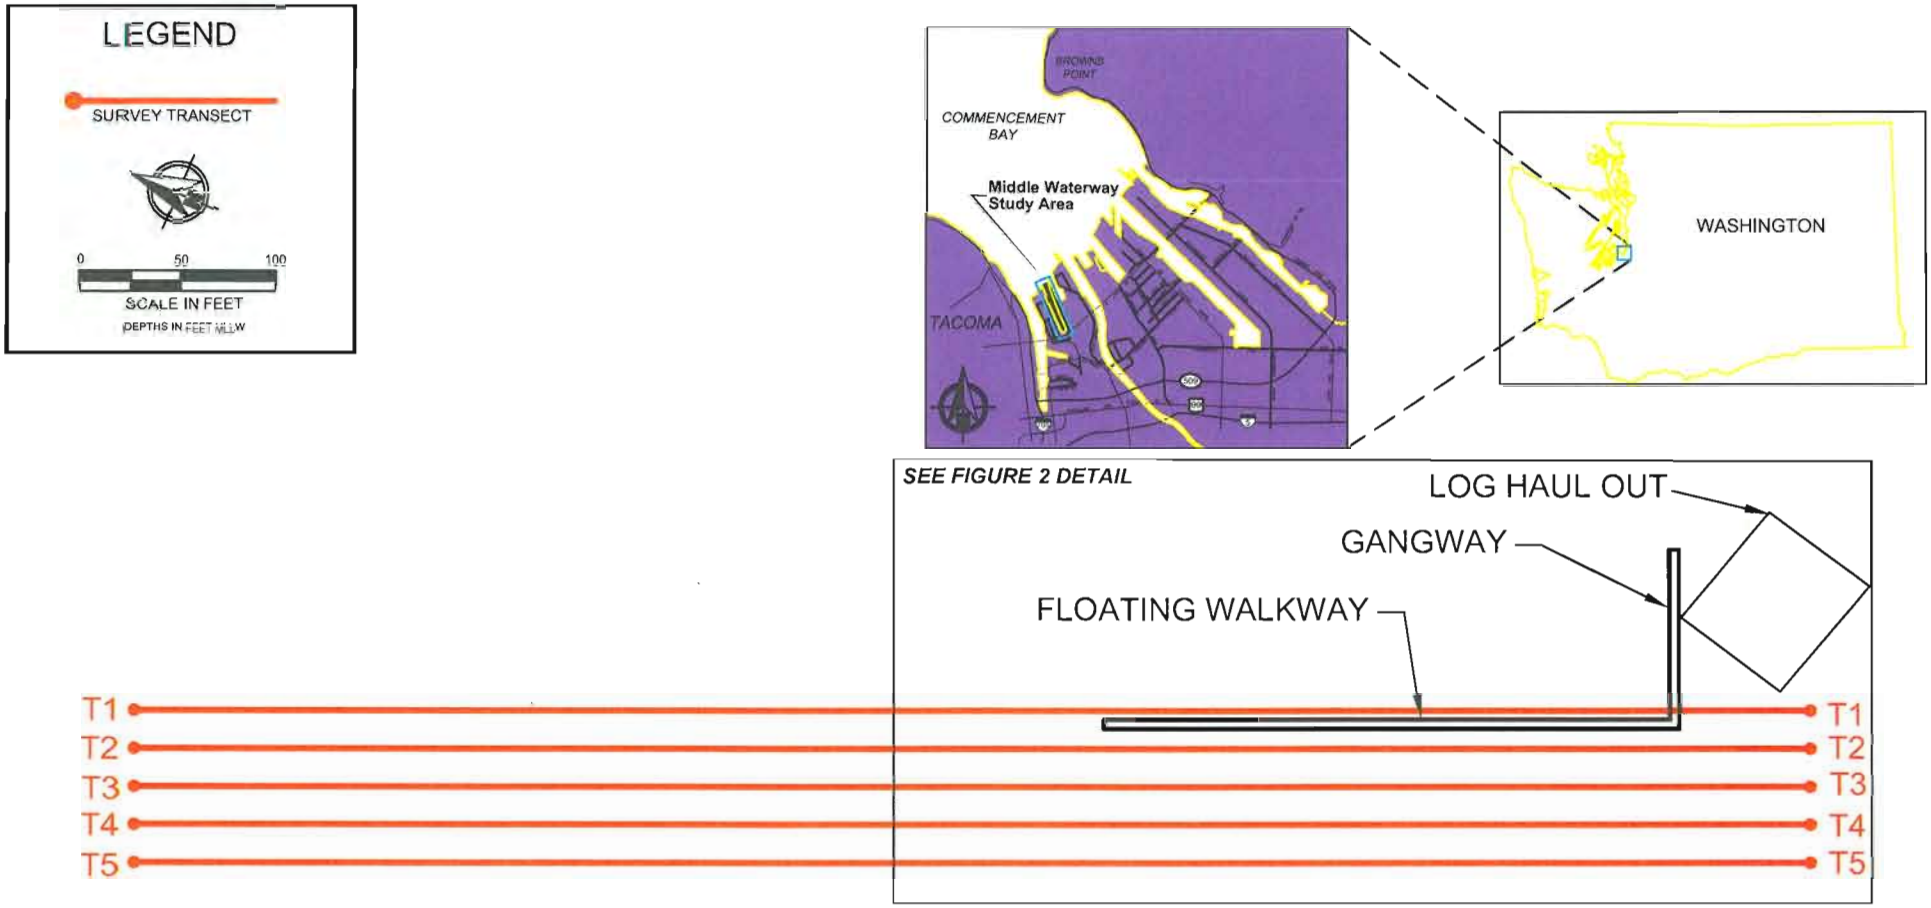
The riprap substrate at the start of Transect 4 had sparse wood debris (<5%), however at 5 ft along the transect tape and within the log lift area, heavy dense bark debris and 12 to 18-in diameter logs were observed, with denser debris toward shore. By 125 ft, bark debris was smaller and less dense, and fewer logs were observed. Along the toe of the shoreline slope, the substrate changed from riprap to mud and divers observed several 2 to 18-in diameter logs. At 215 ft, debris coverage was approximately 30%, decreasing to 15% at 280 ft, and 5% at 325 ft. Substrate composition returned to riprap at 240 ft. At 330 ft, a 10 to 12-in diameter log was encountered. The remainder of the 875 foot transect had no wood debris.

Very little debris was observed on Transect 5. From 0 to 30 ft, divers observed few logs and debris less than 6 in deep. From 30 to 50 ft, wood debris was 12 to 18 in deep and included scattered logs. From 80 to 100 ft, debris was composed of bark sheets. At 150 ft, the density of wood debris decreased to 70% cover and 3.5 in deep. Beyond 200 ft, wood debris on the riprap and mud substrate quickly decreased from 20% to 0% cover.

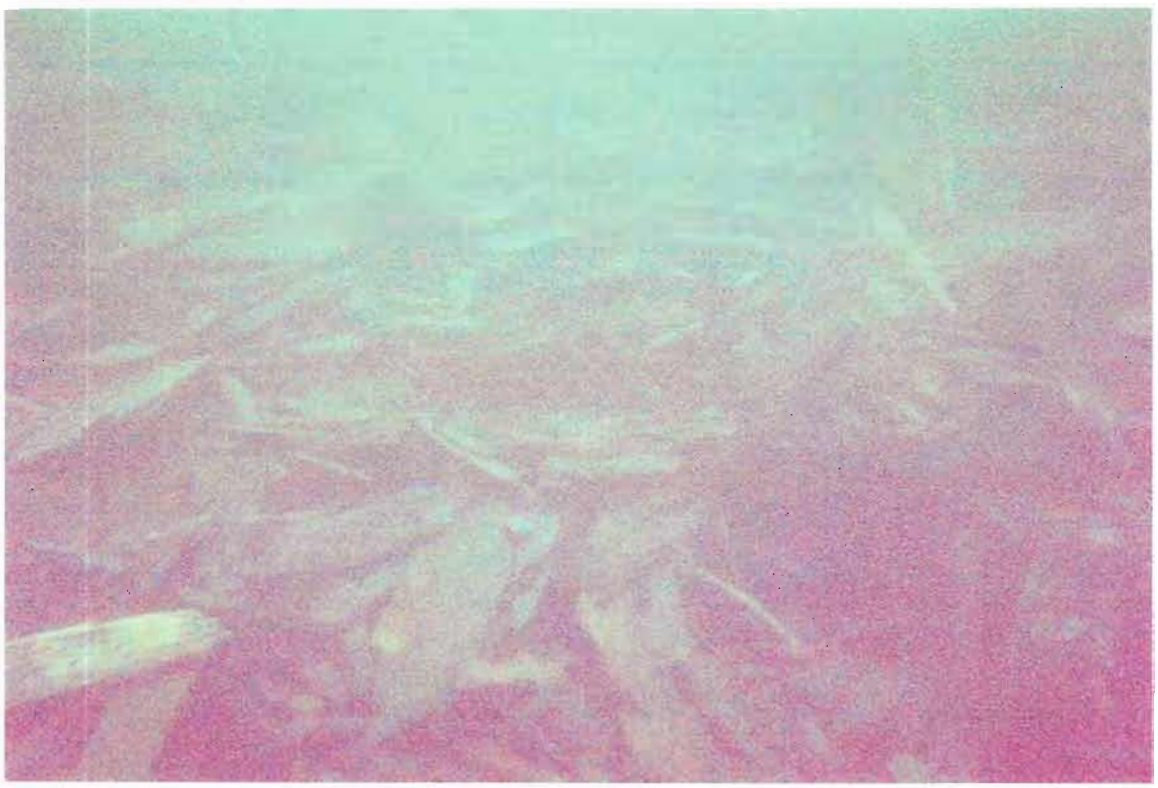
Photo 1. Simpson Log Haul-Out area on March 18, 2005 (looking south).

Photo 2. Bark sheets south of gangplank on Transect 1.
